Report on the excavation of a sawpit in the National Trust Yard, Slindon Estate, West Sussex, April 2008

Following a request from the National Trust, members of the Worthing Archaeological Field Unit undertook the excavation of a sawpit in the national Trust Base Camp yard on the Slindon Estate (grid reference SU 956085). The archaeological objectives were to:

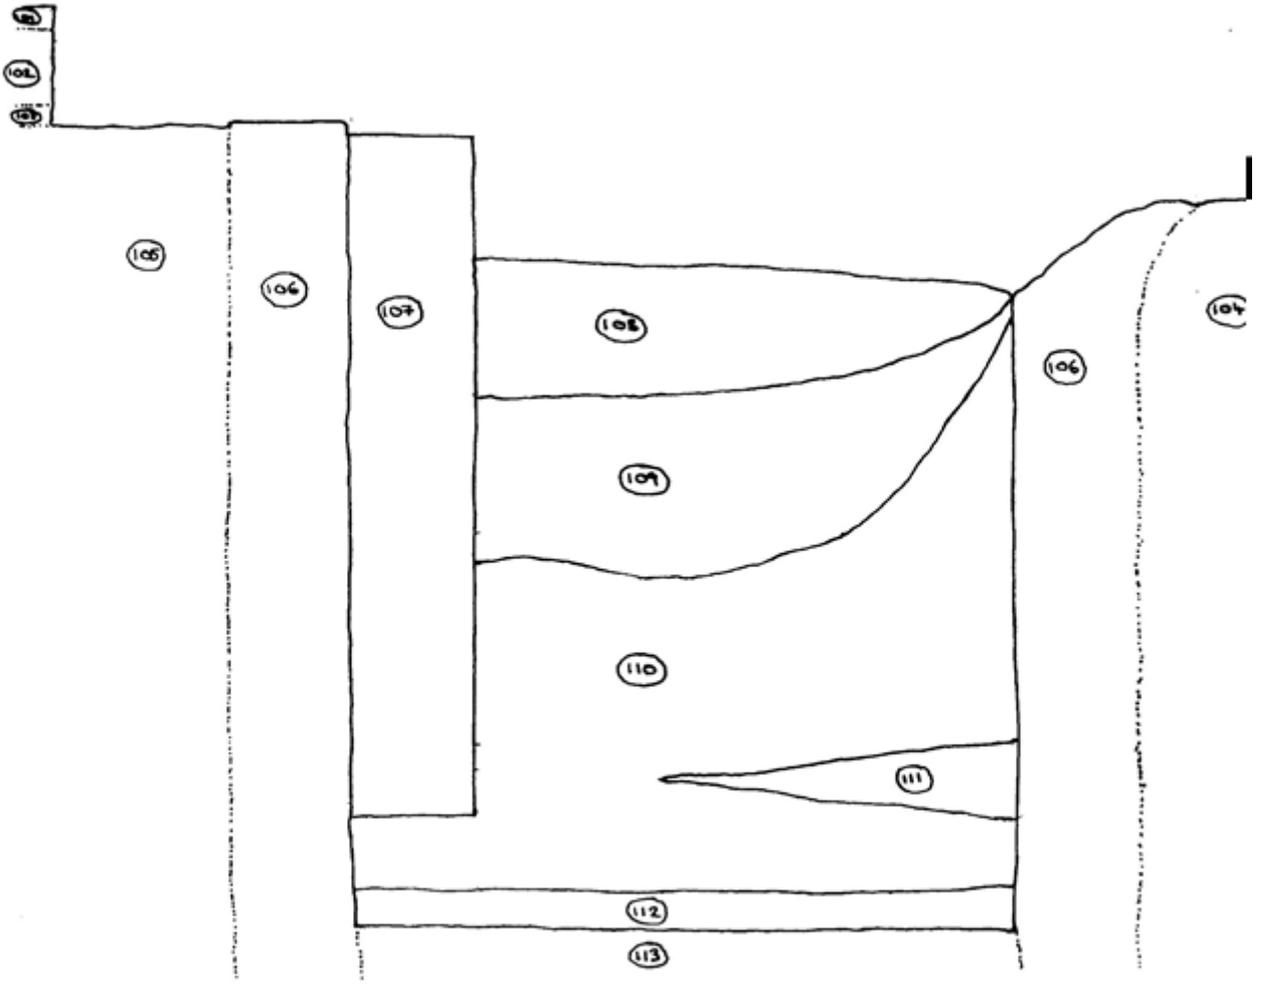
SLY08 Section 1 Scale 1:10

The sawpit is 6.4m long and 2.2m wide. It appears to have been built in two phases. Phase one was the digging of the original pit and its lining with flint walls. These walls were 220-240mm thick and extended to a depth of at least 1.4m. The walls were well made, with sandy mortar bonding the cobble sized flints. A small amount of brickwork was observed in the northern wall. This may have originally formed a niche of some form.

The second phase consisted of the addition of a brick lining to the southern wall and insertion (or replacement of earlier) steps at the eastern end. The wall was made up of 14 courses of white brick (brick size 225x104x67mm), well mortared together, giving it a depth of 1.14m. The top of the brick wall was capped by a layer of mortar, which extended over and originally covered the earlier flint wall (see Plate 2). A large crack ran up from the base of the brick wall to 2/3 rds of its height approximately 3m from its eastern end. Observations beneath the level of the bricks suggest that this structural damage did not penetrate into the earlier flint structure. The brick wall was constructed on top of a laid brick floor (see Plate 3). The bricks of the floor were not mortared together and were placed on a layer of crushed charcoal that contained some brick. The wall and floor were originally joined by a thin layer of mortar, which still adheres to the lowest course of the wall. The floor had collapsed towards the centre creating a void area beneath the brick wall (see Plate 6). The original level of the floor was clearly marked by staining on the northern wall (see Plate 1). Integral with the wall are a flight of steps at the eastern end of the sawpit (see Plate 4). The steps are brick built, there being 5 well-spaced steps, although the drop of the lowest was considerably more than those above (36cm compared to about 22cm).

1. That the Worthing Archaeological Society carry out a desk based assessment of the available maps to try to establish the period that the saw pit was in use
2. That the area of the saw pit be fenced off to prevent vehicles parking over it.
The structure is in poor condition, and it is possible that excessive stress may cause the brick lining of the southern wall could collapse. The top of the northern, flint wall is also fragile and several courses of flint have already been lost on the inner face. A fenced off area, perhaps with a display board showing the results of the excavation to inform visitors about the feature, would help to prevent further damage to the archaeology.
