# A report on the clearance of the Slindon House Stable Block by Worthing Archaeological Society, 2012/13

## A report on the clearance of the Slindon House Stable Block by Worthing Archaeological Society

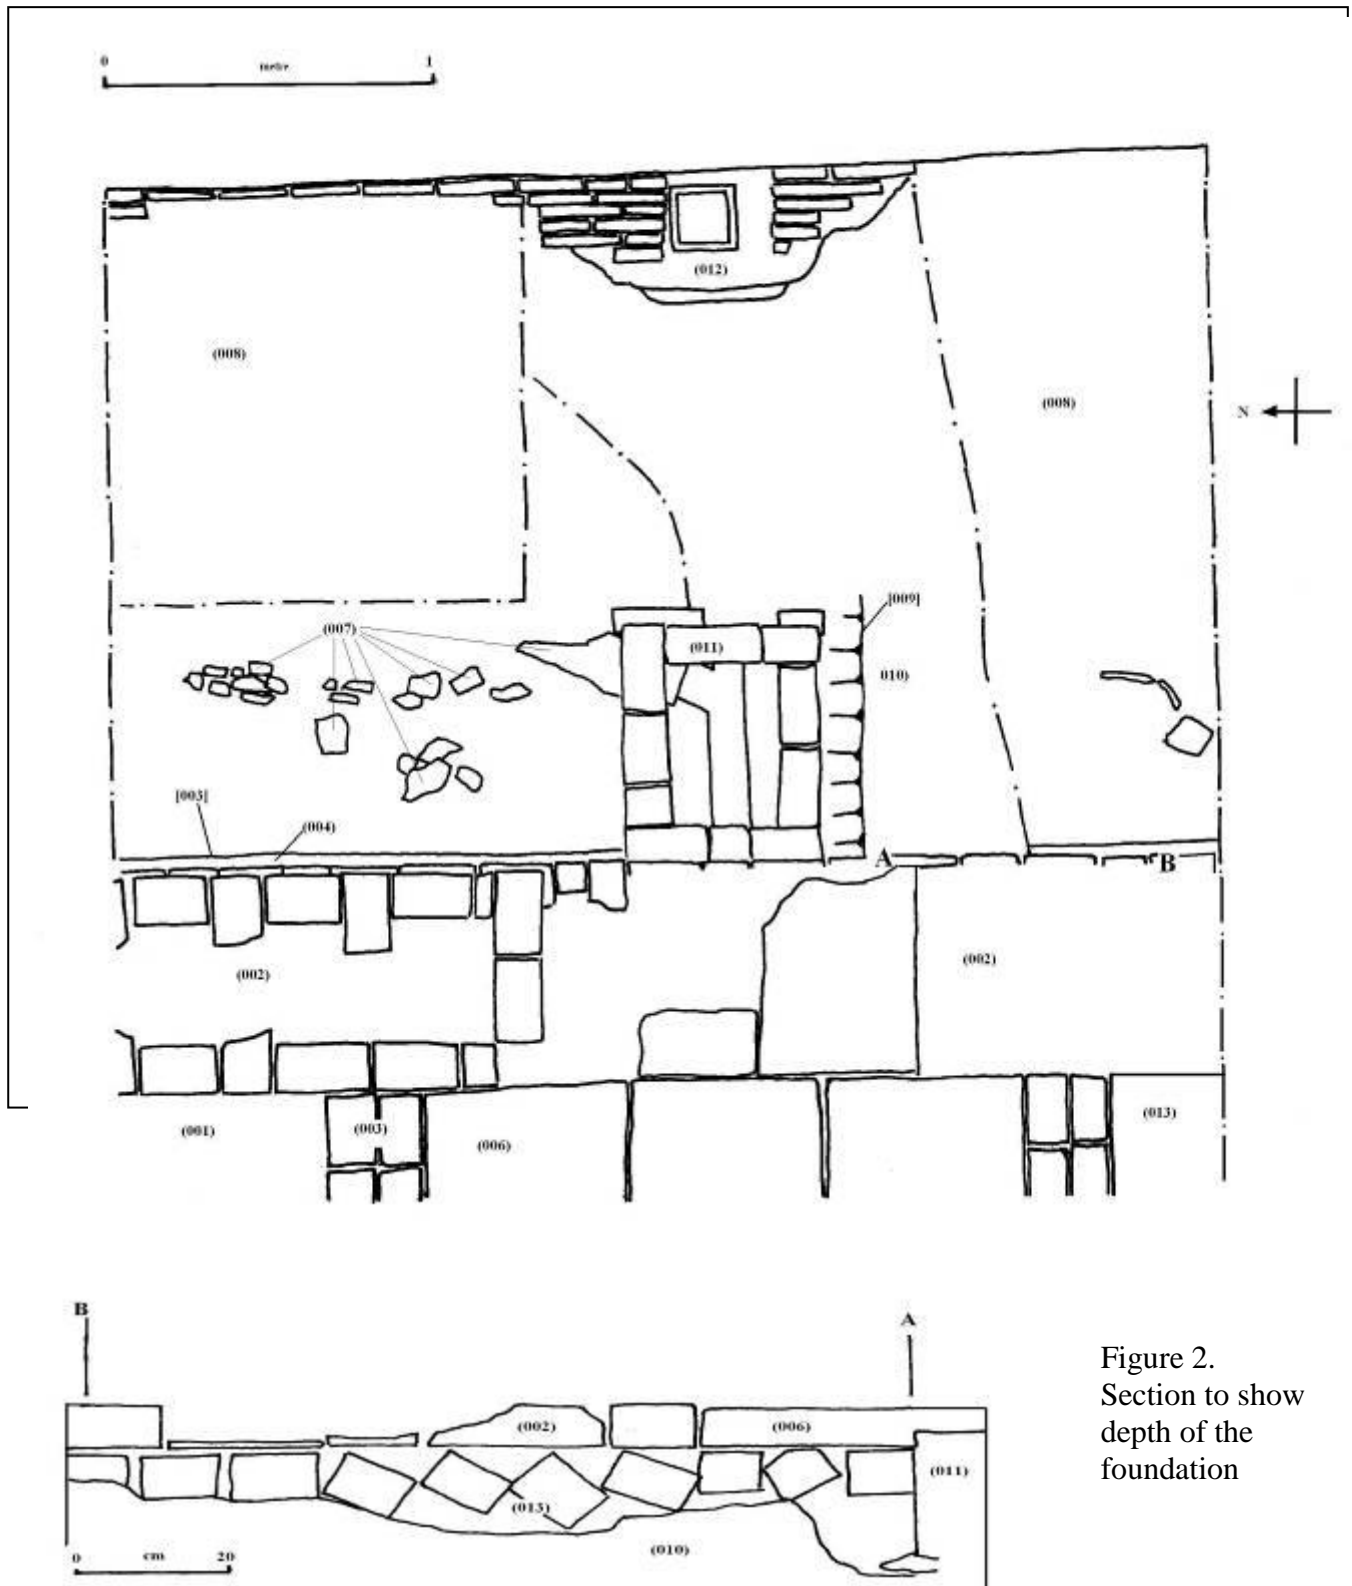
Figure 2.  
Section to show  
depth of the  
foundation

In the area excavated the foundations extend to a maximum depth of 17cm, being founded on solid chalk. They are essentially a leveling feature (composed of brick in mortar) on which the wall was constructed.

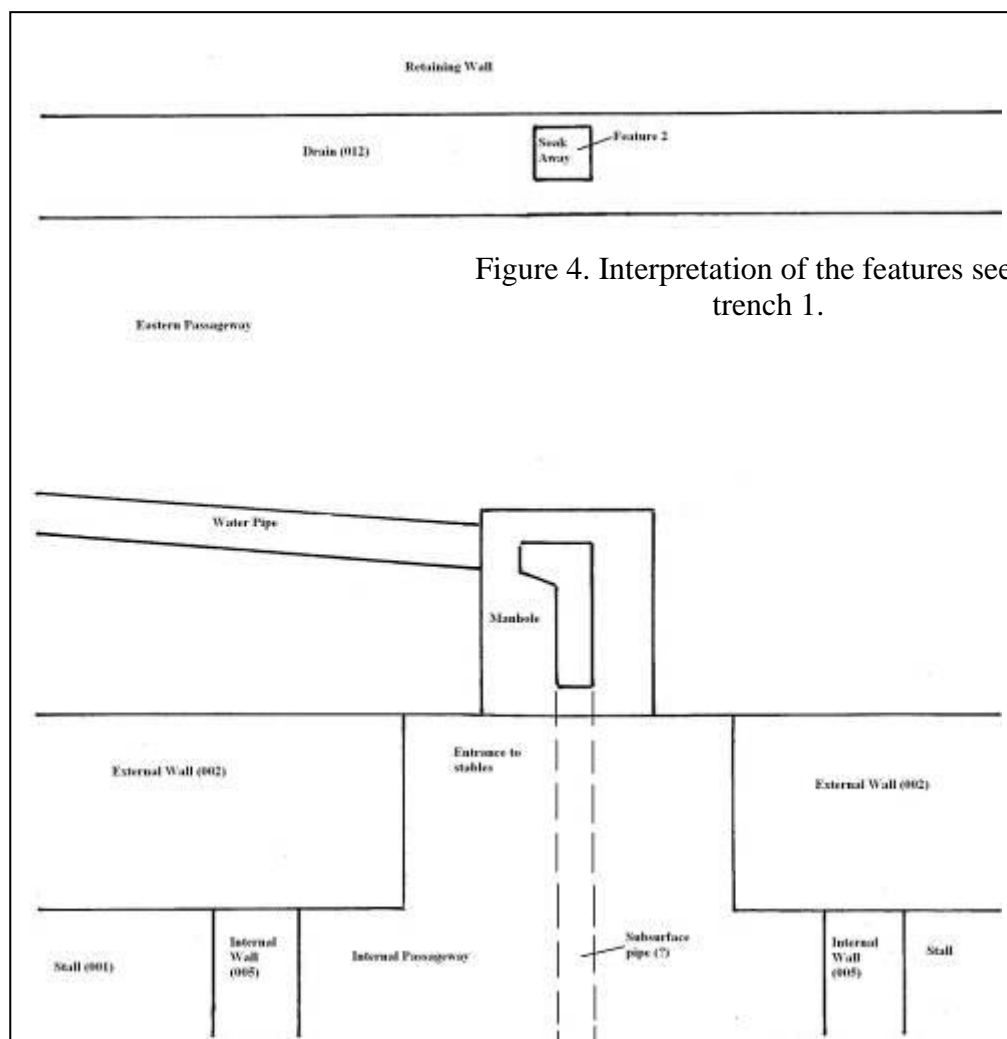
Figure 4. Interpretation of the features seen in trench 1.

Prior to the excavation it was assumed that feature 2 (see Figure 4, an interpretation of the features seen in trench 1), the drain attached to the eastern retaining wall, would link up with the drain that runs beneath the internal corridor. However, there is no subsurface connection between the two features and we currently think that feature 2 lead to a soak away. It, and the associated brick built drain, appear to have been added to the eastern retaining wall, almost certainly to cope with a drainage problem that arose after the construction of the stables.

Context (007) is the shattered remains of a ceramic pipe leading to context (011), the manhole. Initially this was interpreted as a drain, possibly to deal with runoff, via guttering and downpipes, from the roof. Although we have been unable to date any of the materials used in construction, the ceramic pipe is glazed suggesting a late 19<sup>th</sup>, early 20<sup>th</sup> century date

for construction. In addition, the bricks used in the construction of the manhole are bigger than those used in the wall of the building, again suggesting a different phase of construction. The pipe, though shattered and very fragmentary, appears to angle into the manhole in a direction that would lead away from the stables.

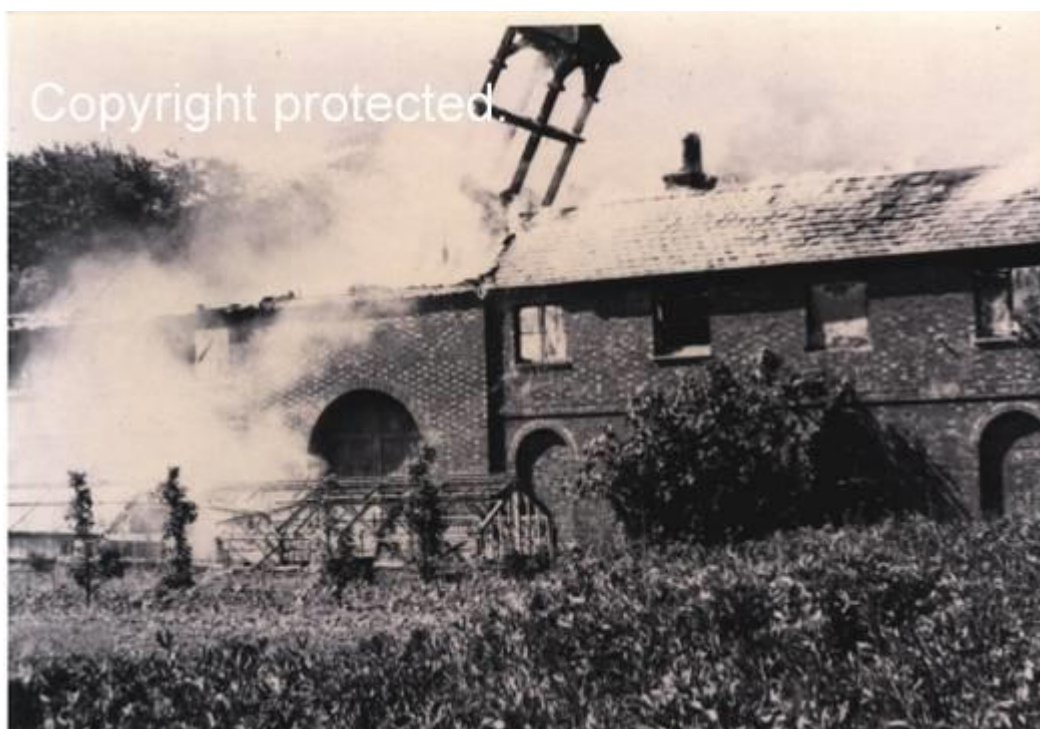
The stable block was struck by fire in the 1960s. (fig.4) There is surprisingly little local memory of this event although there are several photographs. So far no newspaper account has surfaced so these photos provide the best clues to what happened. It seems that prior to the fire the whole building had fallen into disrepair. Perhaps it never recovered from its wartime use. It was apparently used for keeping pigs and for the storage of hay and feeds. The story is that schoolboys from the adjacent school were in the habit of using one of the upper rooms as a smoking den and it is easy to imagine how the disaster developed. The photographs of the fire only show the southern wing but it was plainly well alight, sufficient to burn through the heavy timbers supporting the clock tower. The photographs do not show any fire-fighting activity, maybe the building by this time was so poorly esteemed that it was allowed to burn. Plainly, the debris was later removed down to ground level and the space was reused as a yard.

Fig.4 : The clock tower collapses as fire takes hold of the building

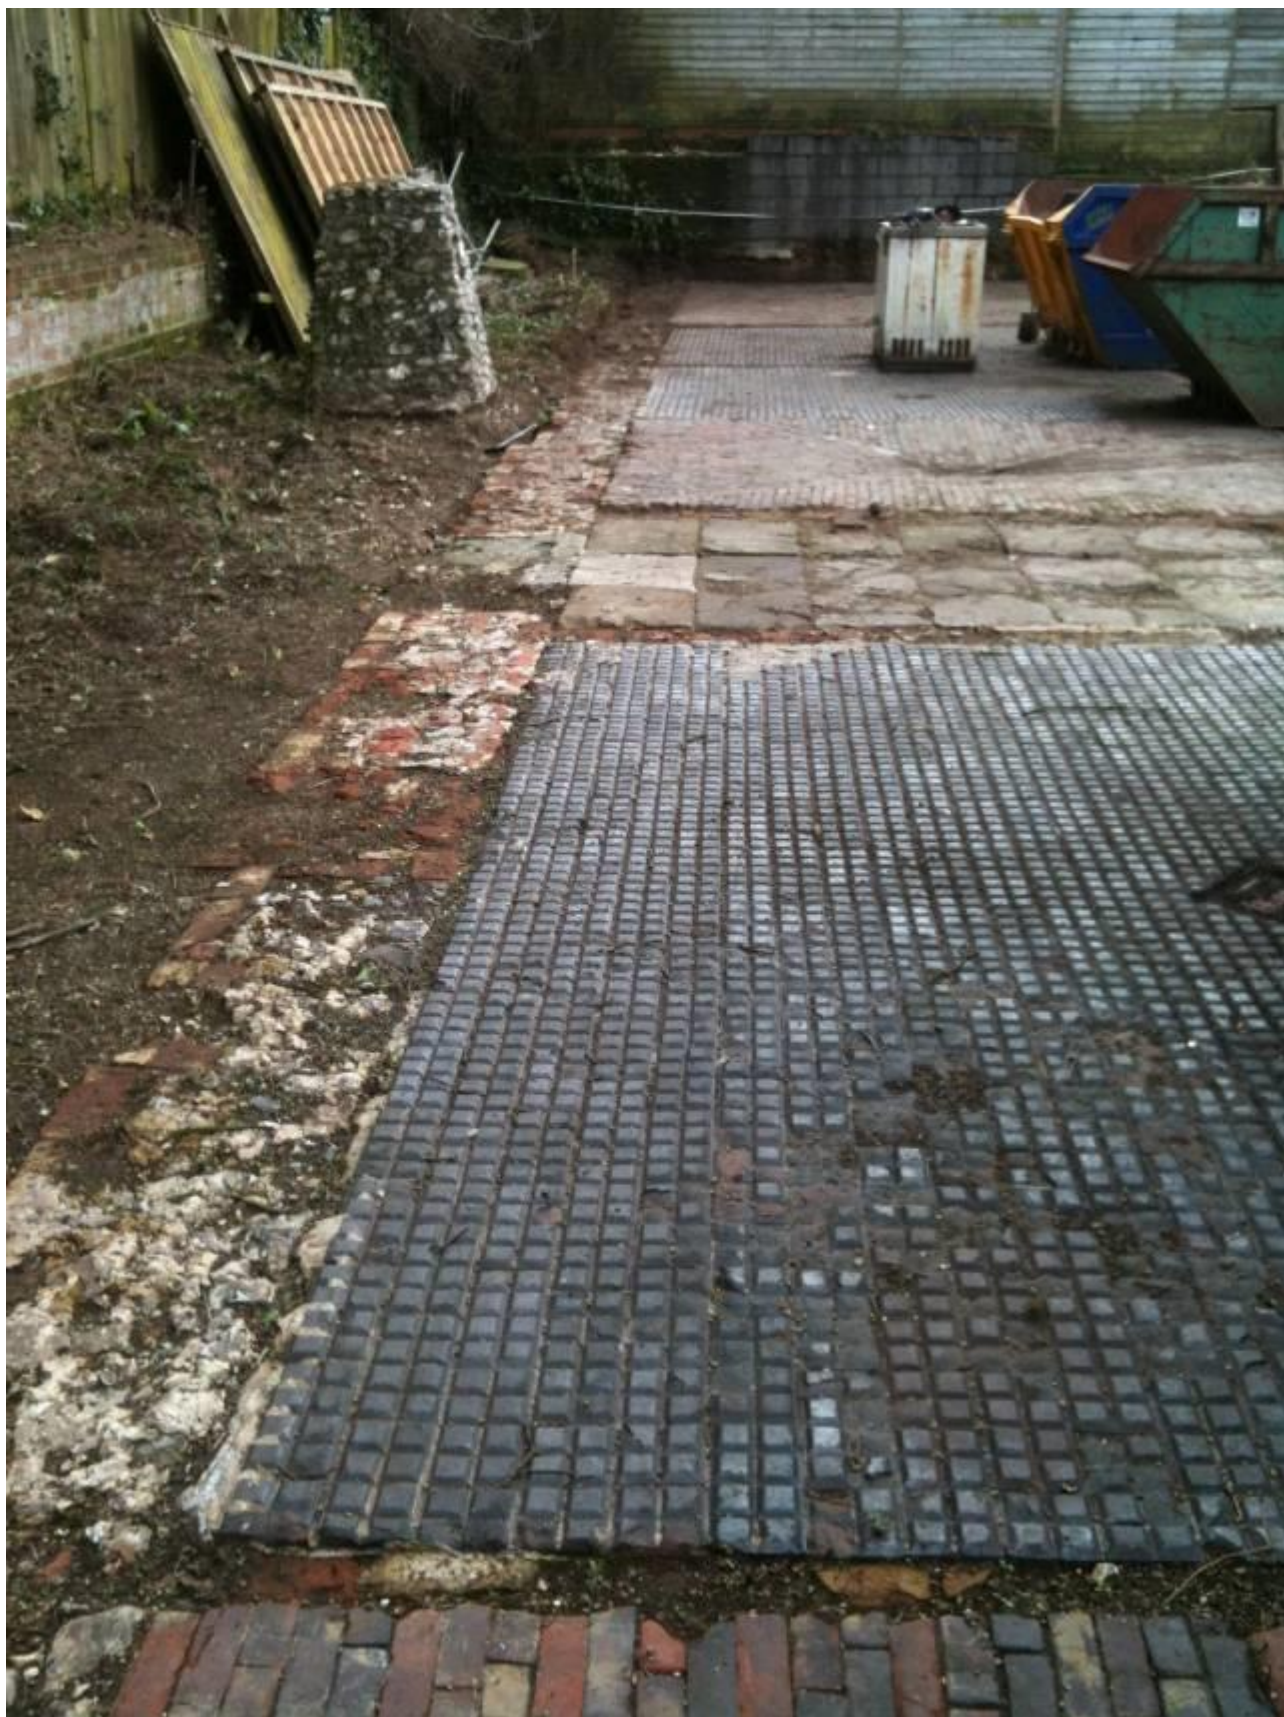
Midway along this range there is a brief change of surface to flag stones. (fig.7) Many of these are broken and laminating but one or two are sufficiently intact to show that they were once thick stones about 18ins x 12ins. They run through the wing from the outside towards the courtyard where a substantial threshold is still in place, creating a narrow passageway. This flagged passage corresponds to the archway that can be seen in the photographs. The passage way is crossed by the herringbone corridor which runs the whole length of this wing. There is a slight evidence of thresholds where the corridor crosses the passage, suggesting that there were doorways opening both north and south, giving access into the corridor. This fits with the layout of surviving stable blocks elsewhere. Going south, the corridor stops at the last loose box which makes the corner with the South Wing.

Fig.7 : Floors of stables, passageway and loose boxes on East Wing, and foundations of outer wall

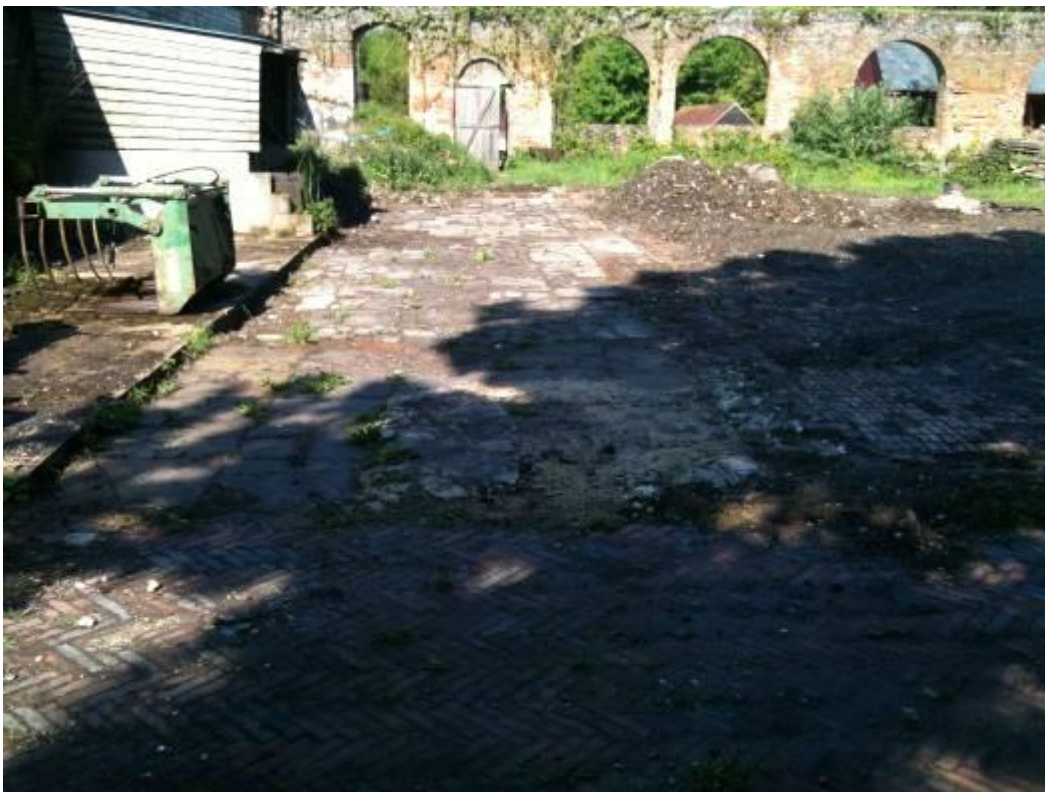
South Wing The floor of the South Wing is completely different. For three quarters of the length it is surfaced with large flagstones. (fig.8) Most of these are now laminating and some are broken but it is easy to see that this was once a substantial and impressive floor. It was probably the coach house and we know from photographs that there were heavy wooden doors on both elevations that would have allowed passage both into and through the wing. There is one exception to this spread; at the start of the flags, against the inner wall of the courtyard, is a patch of thick mortar about 4ft x 6ft laid on top of the flags. This is probably the hearth for a fireplace; one is mentioned in the War Ministry Schedule and this is probably therefore the location of the saddle room which was traditionally the domain of the head groom and usually quite snug. A couple of feet away in the courtyard is a shallow drain gully, often found where a pipe empties through a wall.

Fig.8 : Flagstones of the coach house floor on the south wing

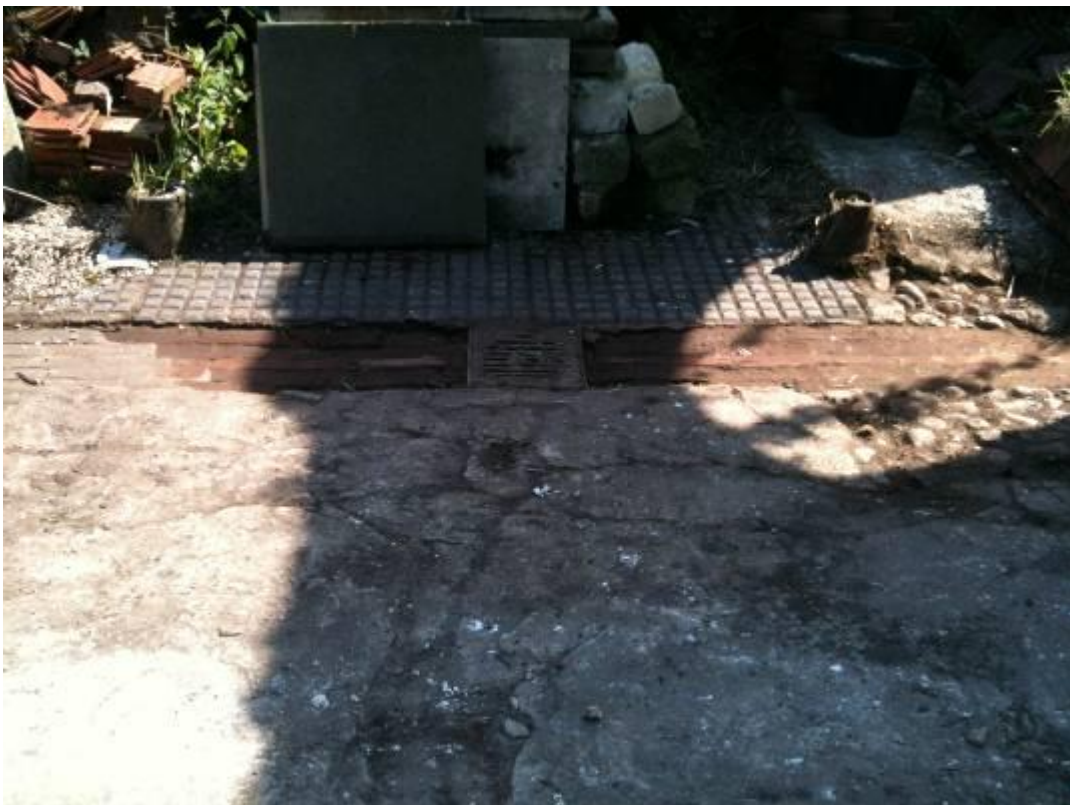
Fig.9 : South west corner showing chocolate block pavers, cobbles and stanchions

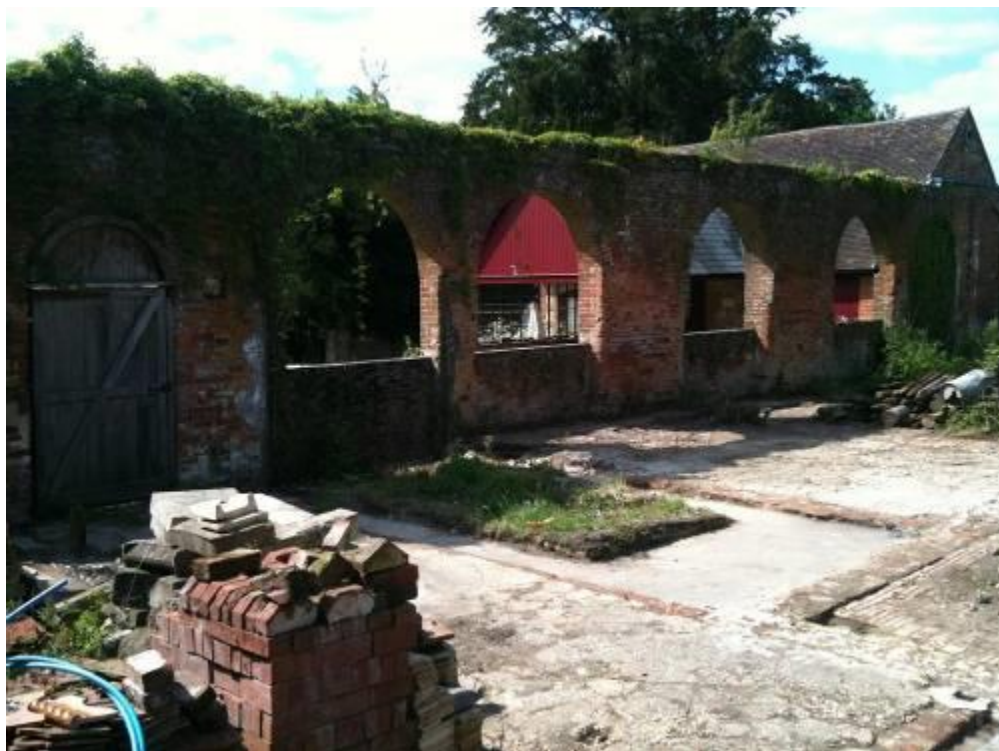
West Wing The outer wall of the West Wing is still standing (fig.10) and therefore ought to give the best clues to the construction and appearance of the stable block. However it can only provide limited information as it is atypical. While we are fairly certain from both photographs and floor plans that the other three wings resembled each other and were symmetrical this wing breaks the pattern, on the external face at least. The other wings each had eight arches on the lower storey, regularly spaced; this wing had two wide arches either side of the central arch and pediment, balanced by a narrow window arch at each end but also pierced by a low doorway near the south end. The two arches at the northern end have been incorporated into the NT office and, at some time, the four central arches have been partially bricked up to nearly half their height. This infilling has been carefully added to match the original brickwork and to correspond to the height of the original window sill beside the stable door. The upper windows on this front were probably blind on the outside but there may have been opening windows onto the courtyard. Indeed, it is likely that the inner face of this wing matched the other three.

Fig.10 : The brick arches of the west wall showing concrete floors and partition walls

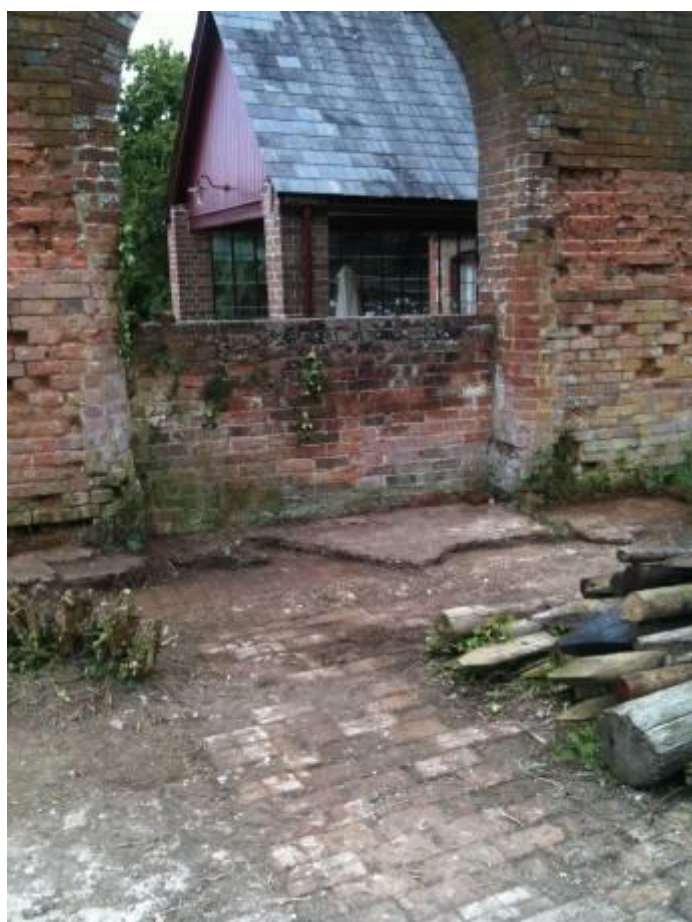
The floors at the southern end of this wing have been concreted over, more than once, and there is a series of post holes about a foot away from the line of the inner, courtyard, wall. These look as if they might have supported a fence or partition and probably relate to some repurposing of the space after the fire. They would not make sense if the inner wall was still in place. Nearer the arches the floors have been broken by a service trench but there is no evidence of the brick floors present in the other wings. There are at least four internal walls running at right angles to the arches and it seems that each arch opened to a room behind. Some of the arches have the pins for gate hinges or doors. Because of the concreting it is not clear whether there were any connecting doors between the rooms. The pillars of the three central arches have chamfered brickwork which would ease the passage of vehicles so we can assume that these rooms were used to store carts, traps and waggons and perhaps, from the early twentieth century, motor cars. The main yard surface continues as a drive for the width of the centre arch. (fig.11)

Fig.11 : Paved driveway from blocked up central arch, showing chamfered piers, concrete overlay and the trench carrying modern services

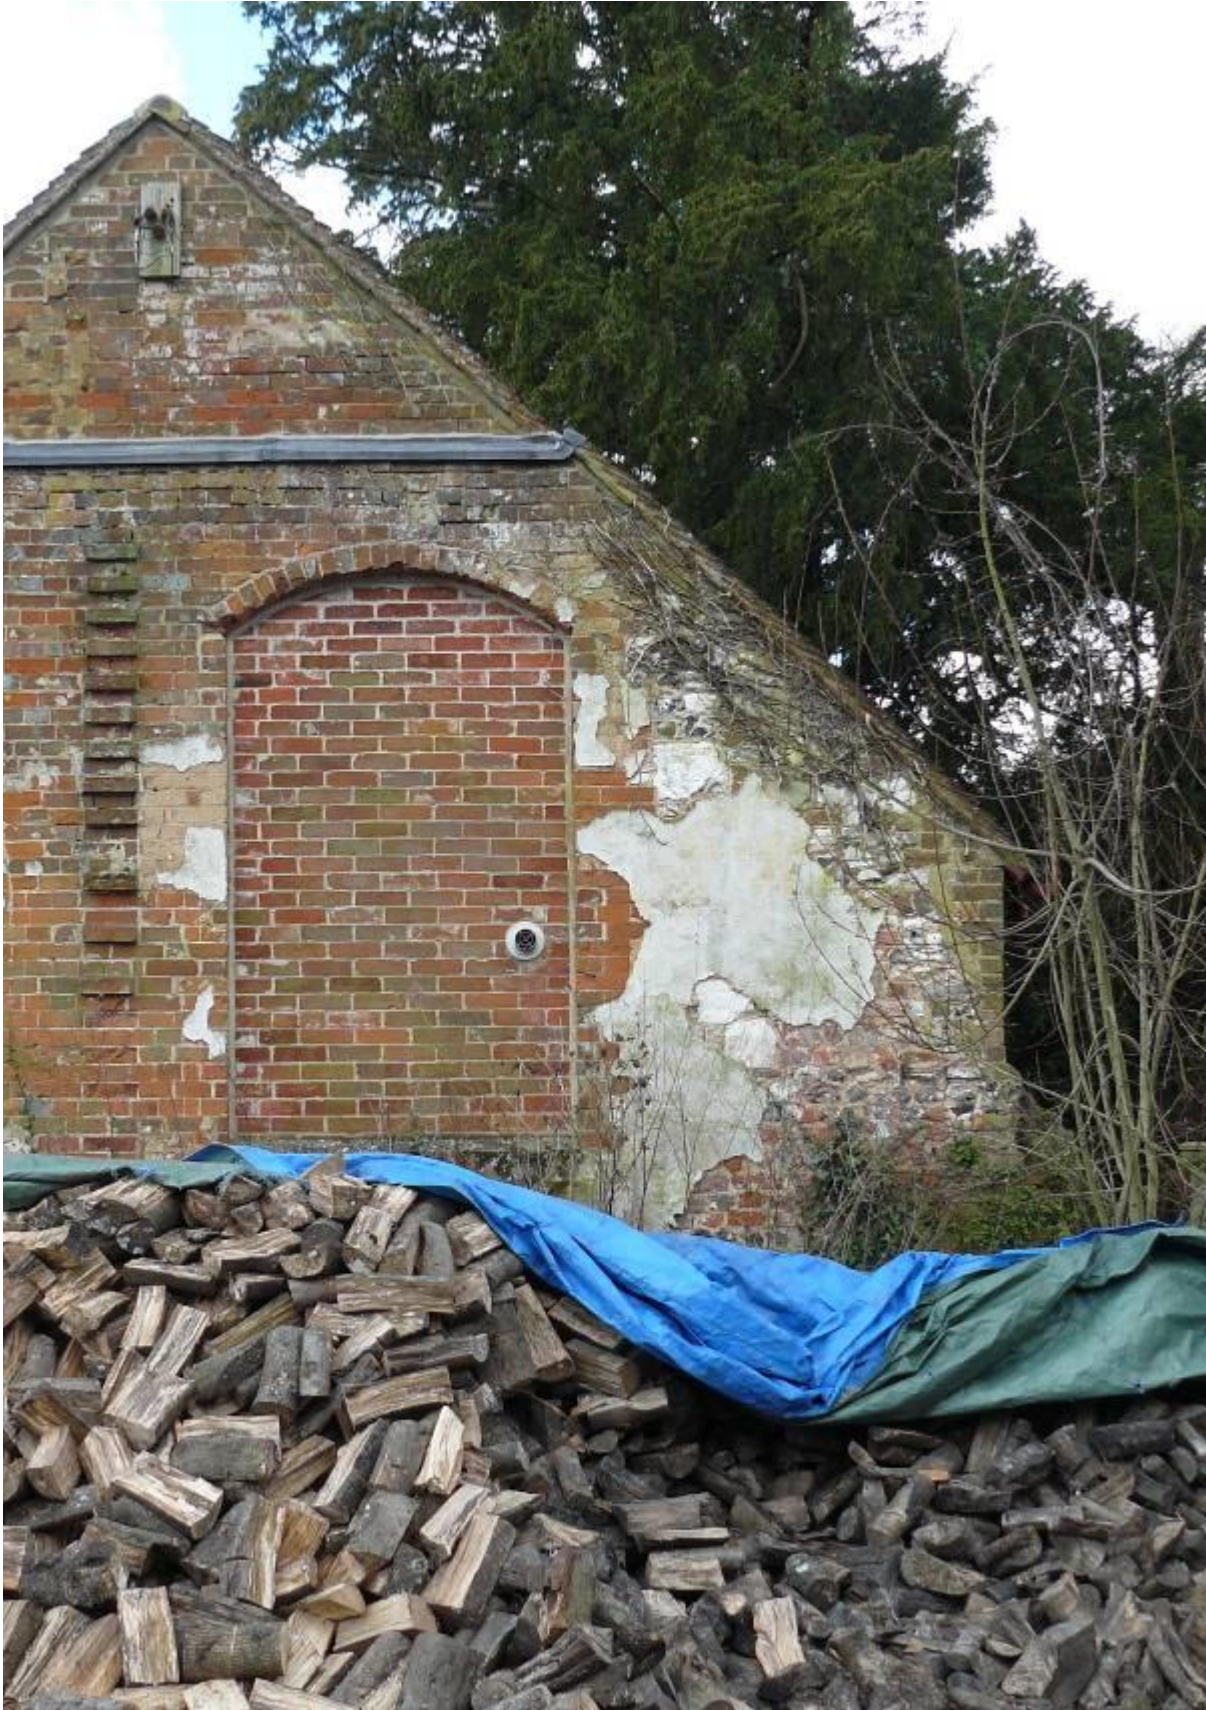
Another possibility is that this NW corner, like the opposite SW corner incorporated an older building. The remnant in the undergrowth and the rear wall of the NT office are of a different construction to the exterior shown in the photographs. Again, these may be glimpses of a less well finished internal face but could also be the result of patching or alterations. (fig. 12)

Fig.12 : Irregular build of NW corner at end of arcade

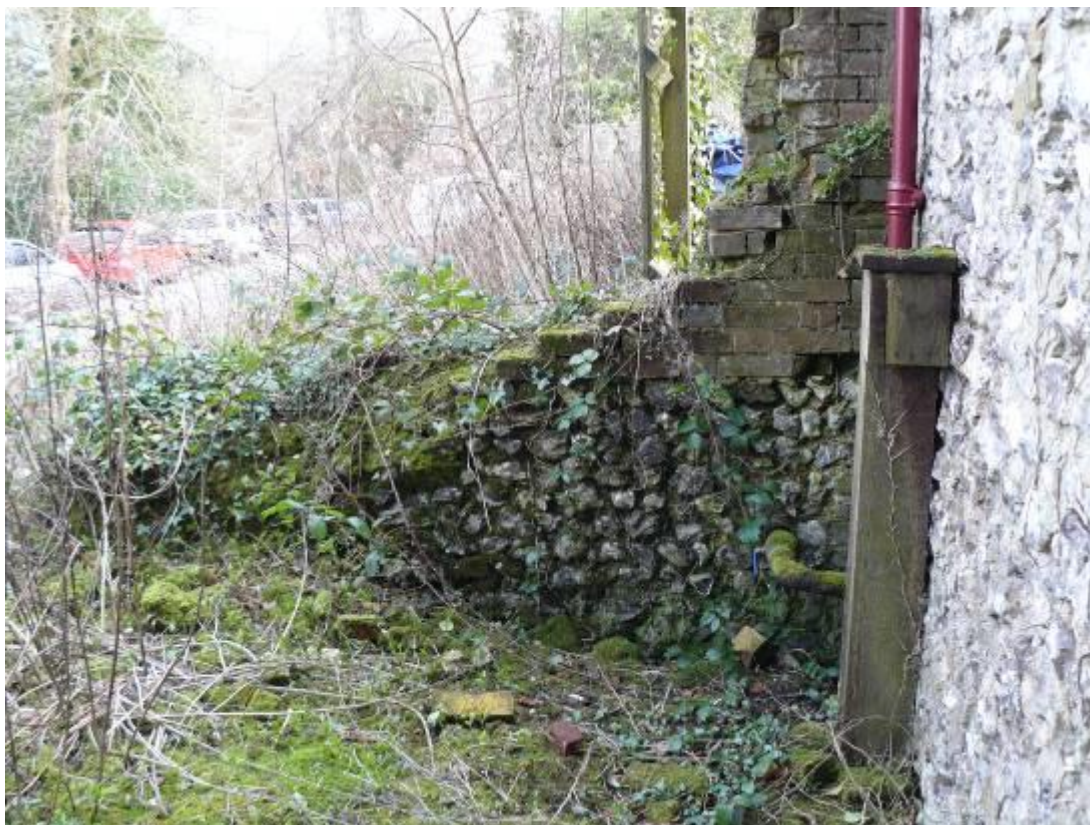
This is the least distinct area of the stable block. Inside the yard it is largely overlaid by timber stacks and by wood chippings to a depth of about a foot. The northern wall lies outside the present fence in a sloping area of grass and brambles. This wall would originally have joined the western arcade several feet from the corner of the NT office. There is a remnant of this junction among the brambles. (fig.13)

Fig.13 : End of the west wall abutting NT office

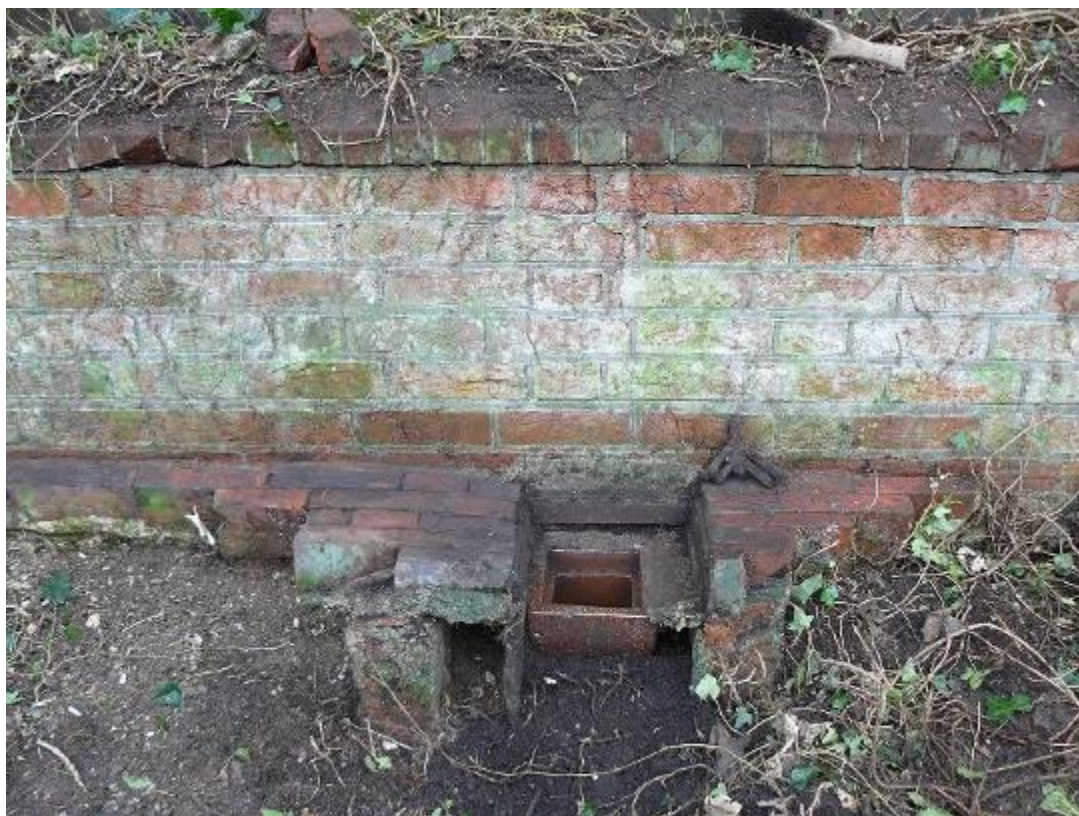
The final feature of note is beyond the line of the east wing. The Schedule describes it as a “dwarf brick wall, 2’3” high with saddle brick coping. To the bottom of the wall is an old brick channel about 12” wide falling to a gully in the centre, complete with grid.” (fig.14) Although the wall is still intact, now capped by a fence marking the boundary between the NT yard and the College beyond, the channel has collapsed for much of its length. However, enough remains to show that it was constructed of the same bricks as the stable floors, with five or six laid edgewise with careful cambering to create a concave channel exactly like those inside the stables.

The College ground rises quite steeply behind this wall and our best guess at the purpose of this wall is that it was built to overcome a problem with seepage. It may not have been part of the original design but added later to drain water out of the slope, hence the channel to direct the seepage to the gully.

Fig.14 : Retaining wall, brick channel and gully on east boundary of site
