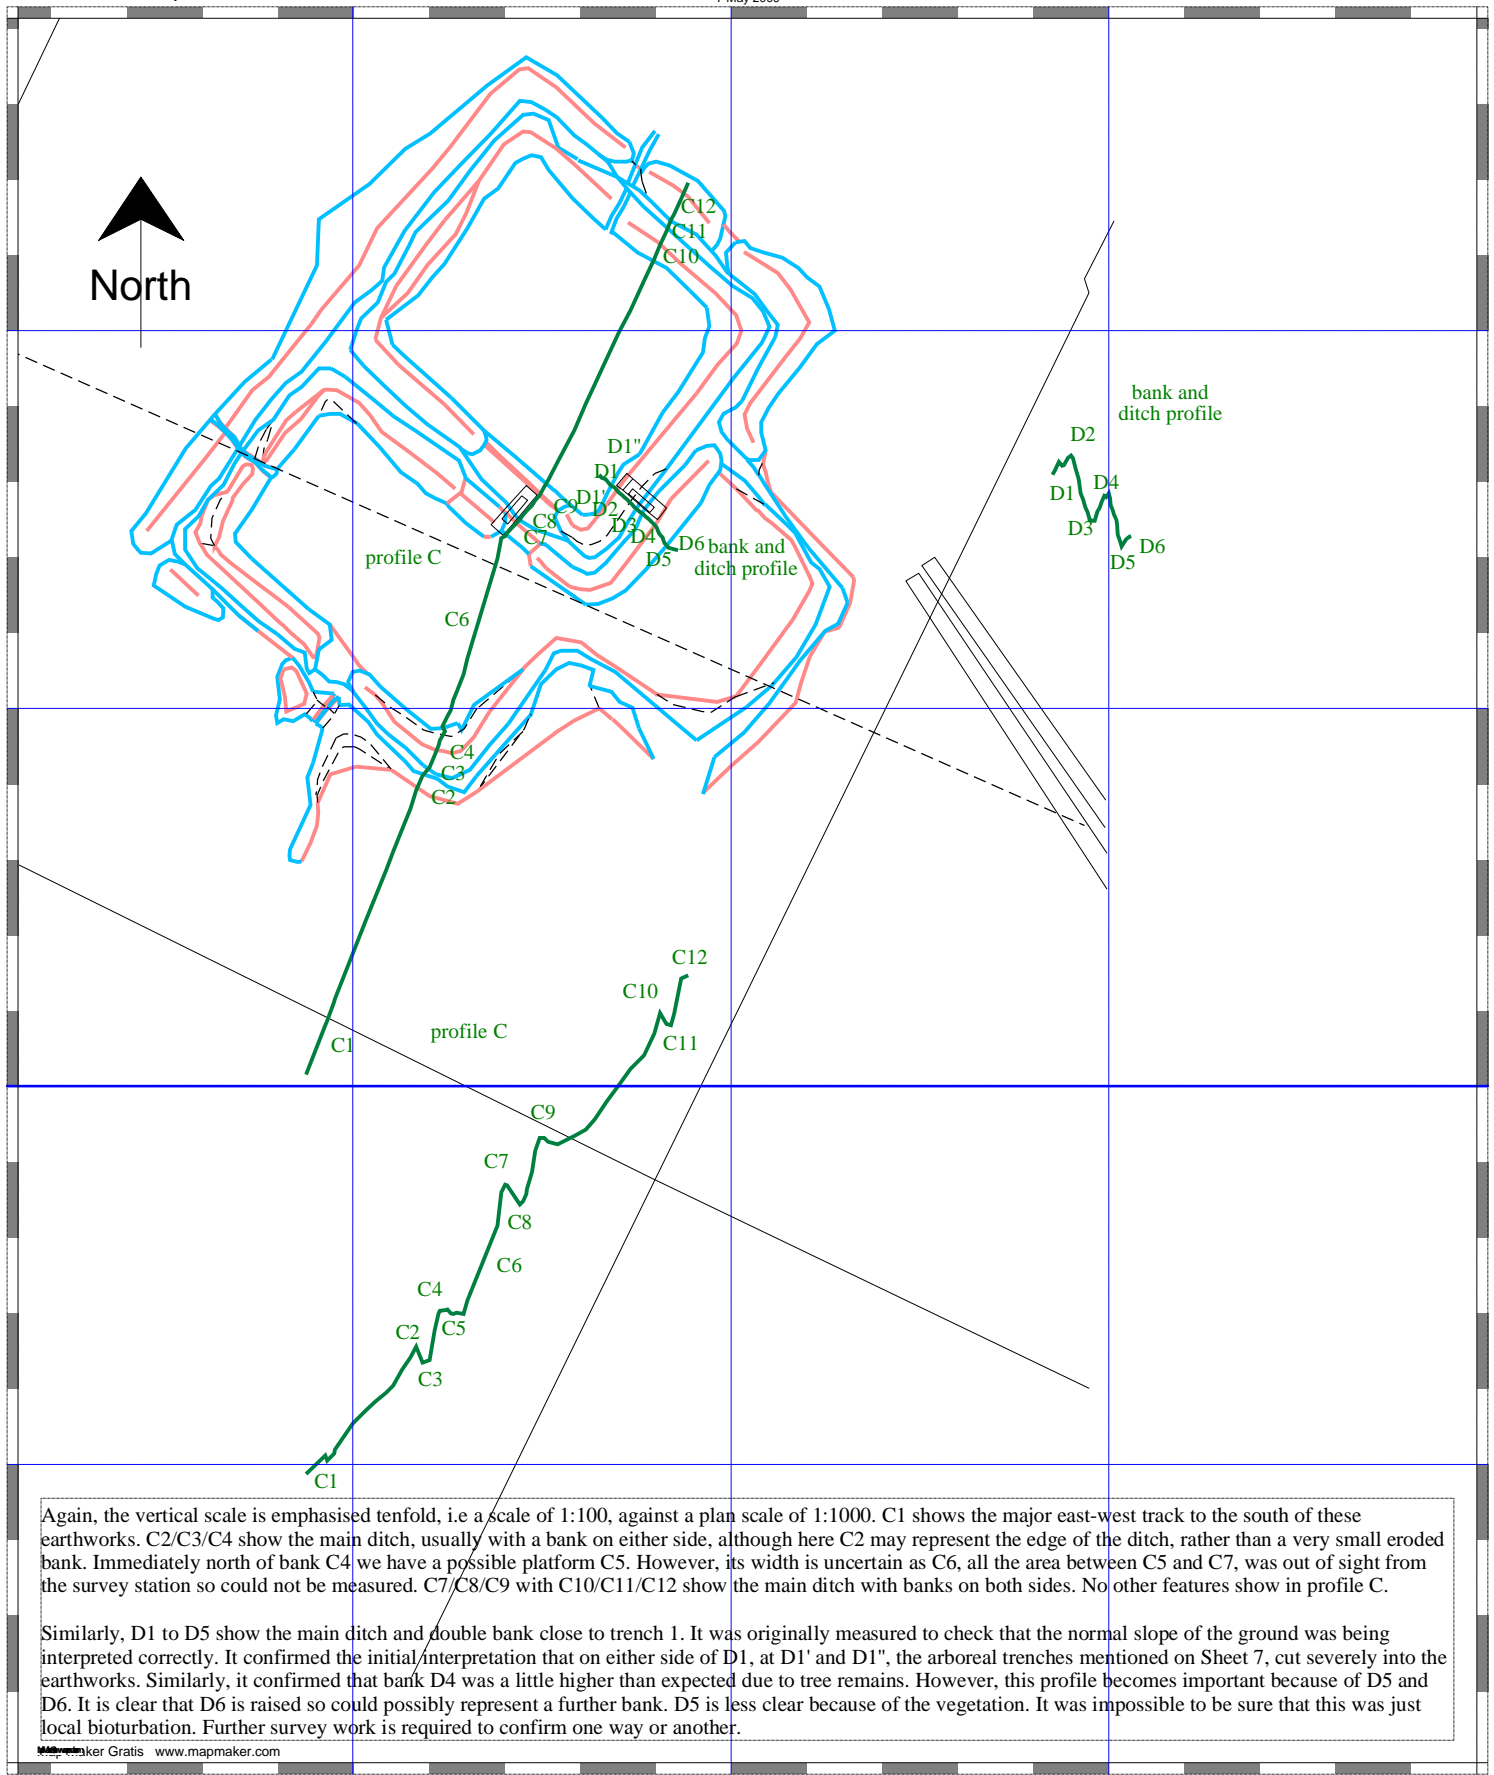
Again, the vertical scale is emphasised tenfold, i.e a scale of 1:100, against a plan scale of 1:1000. C1 shows the major east-west track to the south of these earthworks. C2/C3/C4 show the main ditch, usually with a bank on either side, although here C2 may represent the edge of the ditch, rather than a very small eroded bank. Immediately north of bank C4 we have a possible platform C5. However, its width is uncertain as C6, all the area between C5 and C7, was out of sight from the survey station so could not be measured. C7/C8/C9 with C10/C11/C12 show the main ditch with banks on both sides. No other features show in profile C.

Similarly, D1 to D5 show the main ditch and double bank close to trench 1. It was originally measured to check that the normal slope of the ground was being interpreted correctly. It confirmed the initial interpretation that on either side of D1, at D1' and D1'', the arboreal trenches mentioned on Sheet 7, cut severely into the earthworks. Similarly, it confirmed that bank D4 was a little higher than expected due to tree remains. However, this profile becomes important because of D5 and D6. It is clear that D6 is raised so could possibly represent a further bank. D5 is less clear because of the vegetation. It was impossible to be sure that this was just local bioturbation. Further survey work is required to confirm one way or another.
