# St Nicholas' Church

# The History of St Nicholas' Church, Angmering

# The 2015 Project Plan

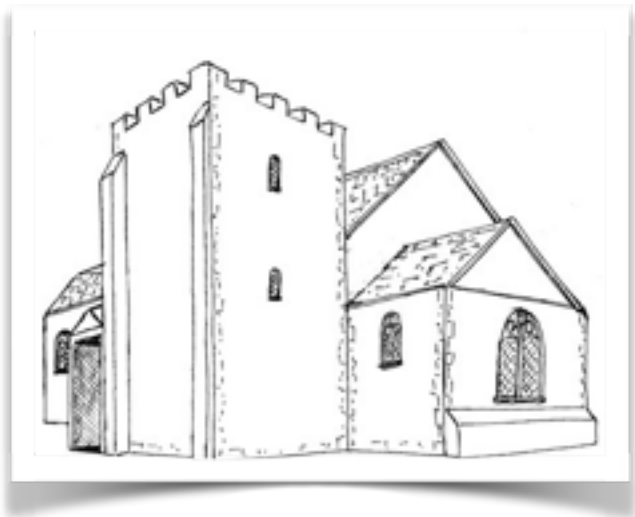
St Nicholas' Church Drawn from Bedwin's plans - © Bob Turner

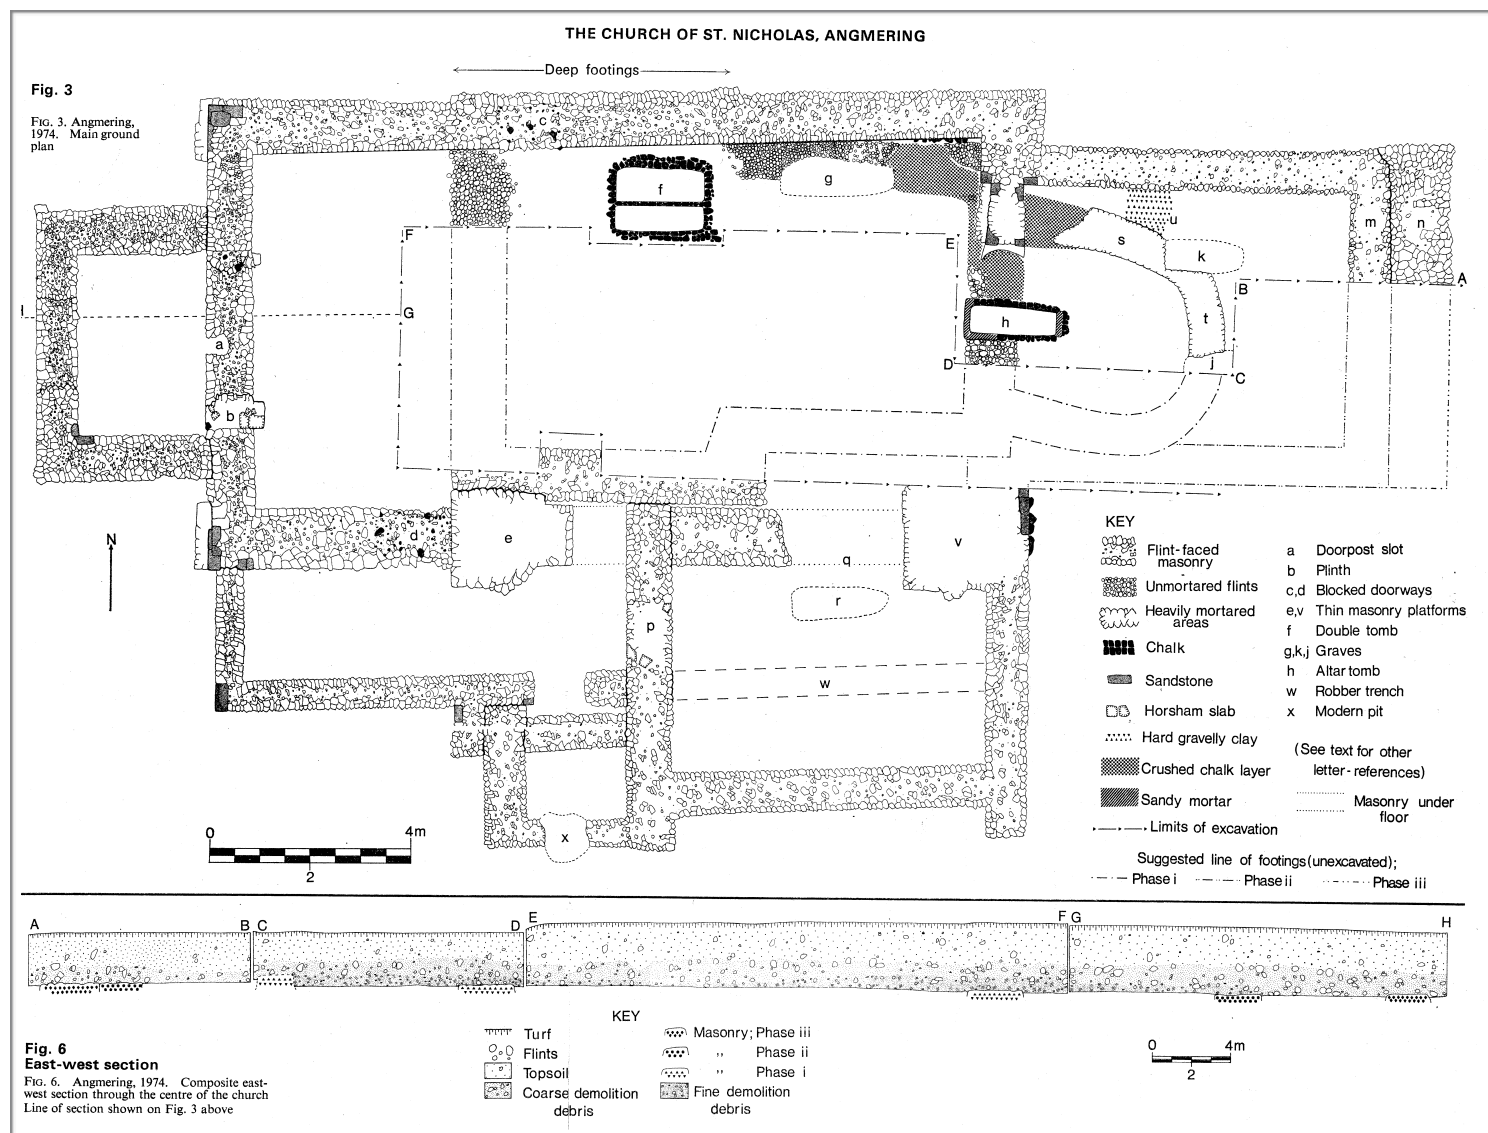
The 1974 Excavation Plan of St Nicholas' Church, Angmering (Bedwin, 1974)

During this project Bedwin focused on establishing an overall floor plan for the church, and began to develop a timeframe of its phases of construction and change. However Bedwin's excavation was carried out using archaeological methods of its time, with the trenches being

placed through a combination of onsite observations, old maps and records intermixed with a little bit of luck (Bedwin, 1974). Today, thanks to developments in technology, archaeology can map the church to a much finer degree of accuracy. There are also several areas of the site where questions still need to be resolved, such as the relationship between the Norman and Saxon Chancel walls, on the south side of the church.

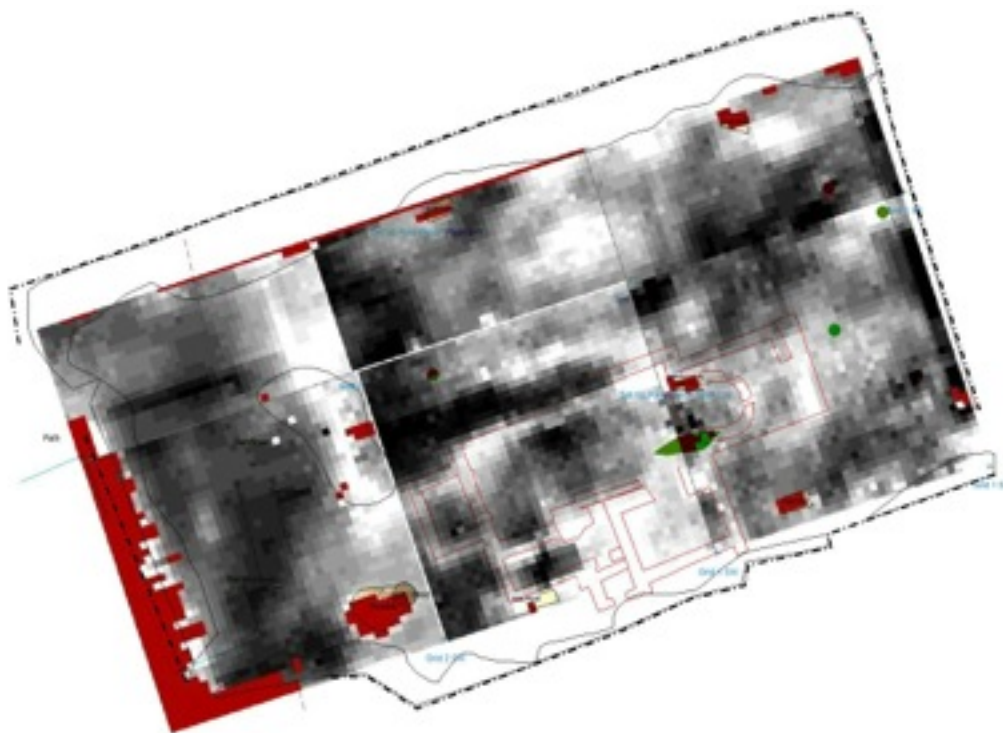
Results of the Geophysical Survey

During the 1970's the site of St Nicholas' Church was almost completely excavated. This excavation was extensive, however due to recording methods of the time there is no way to accurately plan out the church's foundations, from the original site records. As such the first phase of the project will see the completion of a geophysical survey, using a method called resistivity. This type of survey involves running an electrical current through the soil and measuring the levels of resistance to that current. In soils which contain a lot of moisture the resistance will be minimal. In contrast, soils with large, dry sections of masonry will register much higher levels of resistance. By taking frequent, systematic readings across the field a pattern of electrical resistance will be formed and the outline of the church will be roughly plottable.

This trench will firstly try to establish the northern wall of the church, working from the resistivity survey and Bedwin's plans. Secondly the trench will examine an anomaly identified from the geophysical survey to the north of the Norman church wall.

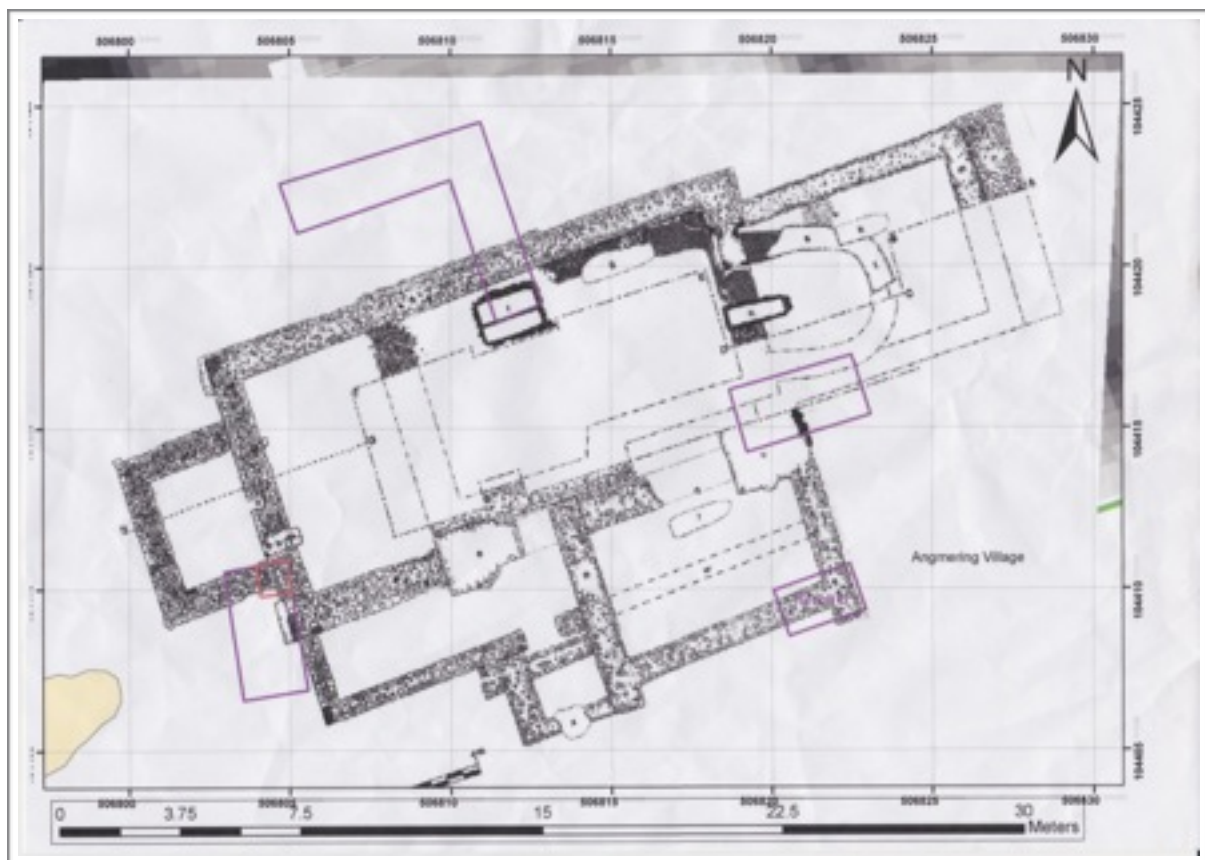
The final plan for trenches A,B,C and D - 2015

Prior to the opening of the site the planned area of excavation underwent a few slight amendments. The original trenches were located based on the geophysical survey but due to physical obstructions on site, such as the flower beds and central tree, the location of trenches A and C needed to be slightly altered. The final planned layout of trenches A,B,C and D for the 2015 excavation is shown below.

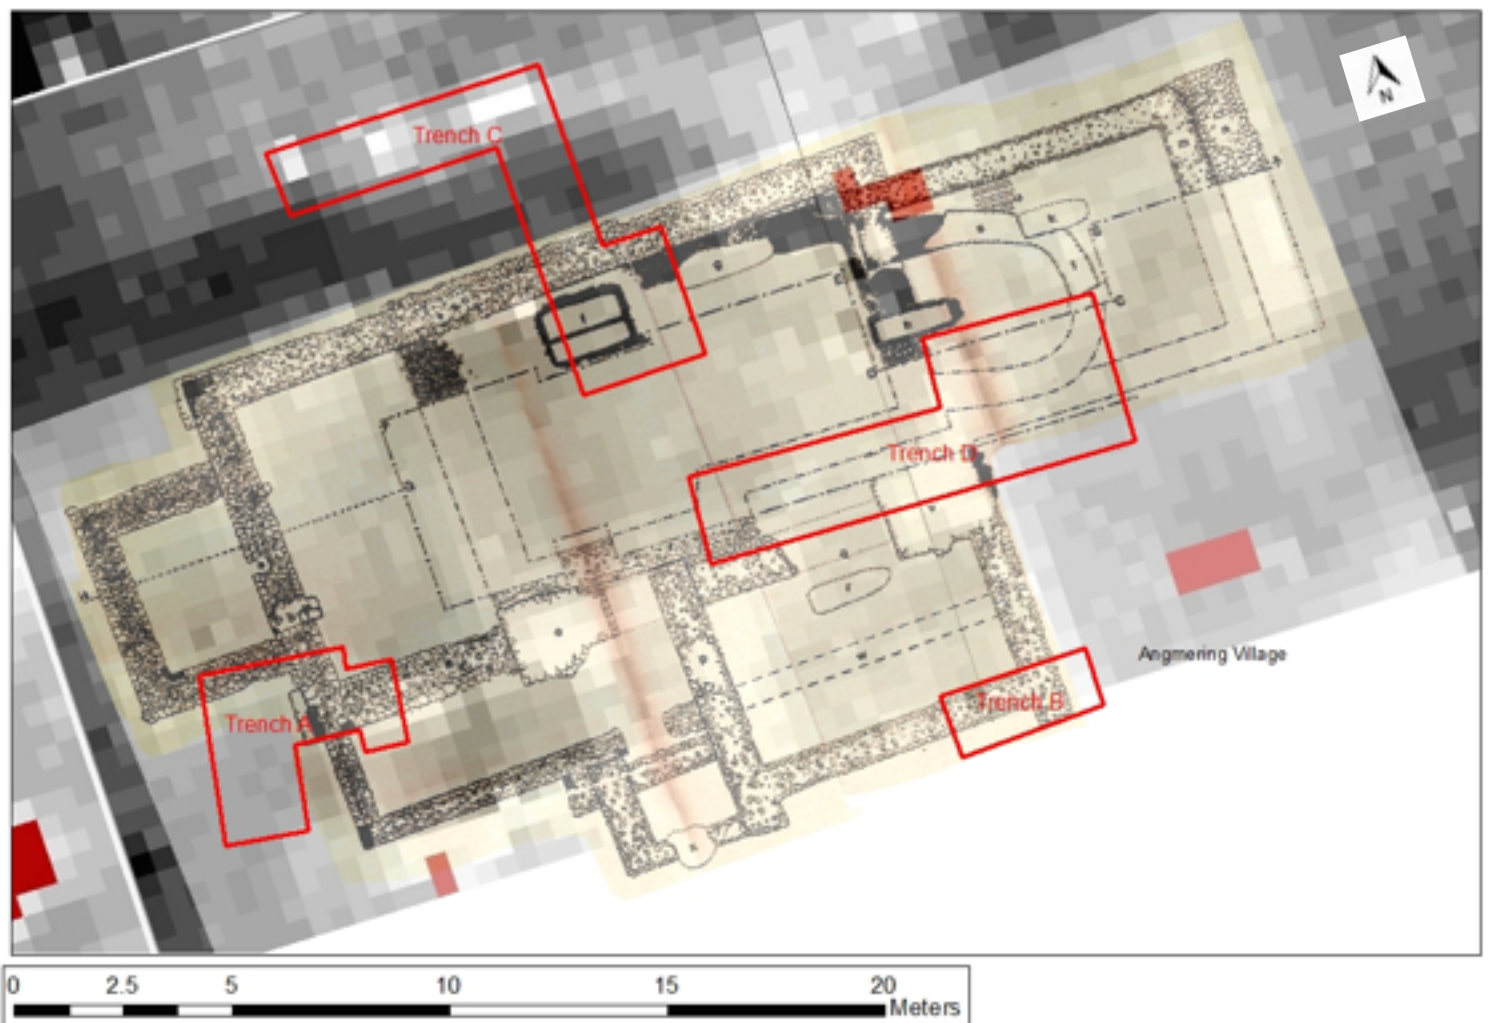
2015 Trenches overlaying Bedwin's 1974 excavation plan.

With the help of the local community, including all of the school children involved in the St Nicholas project, trench A was dug to a depth of 70 cm. The church walls in this trench were located using a sondage (a smaller trench dug within an existing trench) at a depth of 60cm. Three intersecting structural walls were found in trench A, all constructed of flints placed within mortar.

These wall lines are seen on Bedwin's original excavation map and are listed by him as being;

- ❖ The south wall of the porch.
- ❖ The N/S wall which defines the western end of the Norman church nave.
- ❖ The E/W southern wall of the Norman nave.

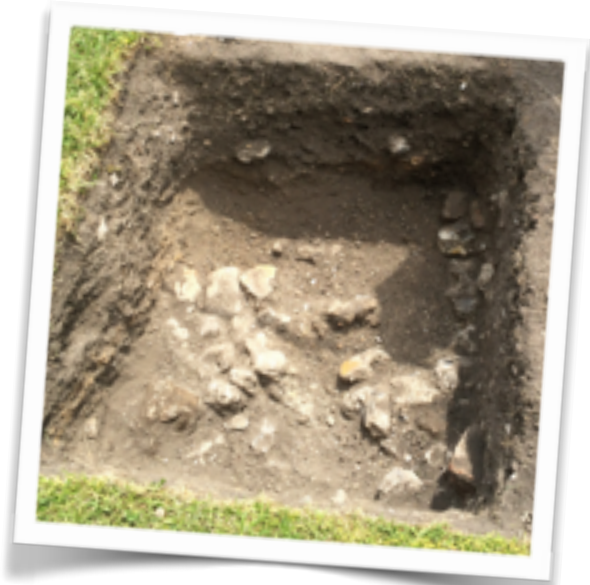
Masonry wall found in trench A using a sondage.

Each of these sections of masonry wall were constructed into each other, which would suggest that they were all part of one phase of the churches development. During the excavation a small hole was discovered within one of the walls in this trench which was not mentioned in Bedwin's excavation report. This hole was built into the wall, rather than having been made due to some form of destruction and would appear to have been the foundation for a structural post included within the wall itself. This is not an uncommon structural technique. Internal wall posts can be used as part of structures built on to slopes to give the wall extra support, particularly if the wall is a crucial load bearer. There were also small amounts of white wall plaster found on the walls within this trench suggesting that the church itself would have once been well decorated.

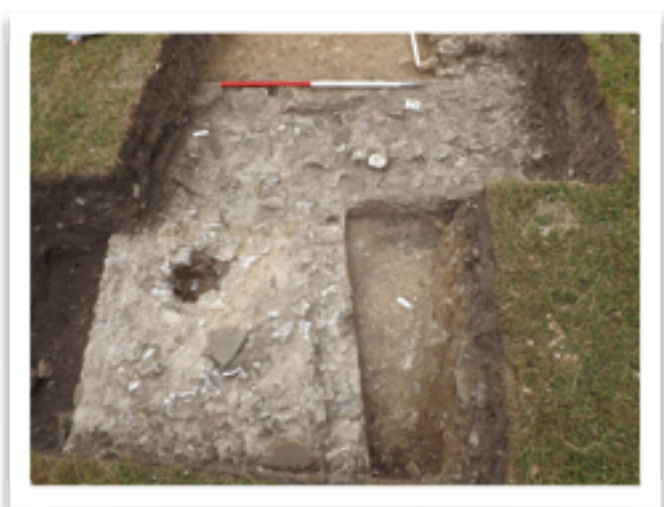
Small support structure post-hole— Trench A

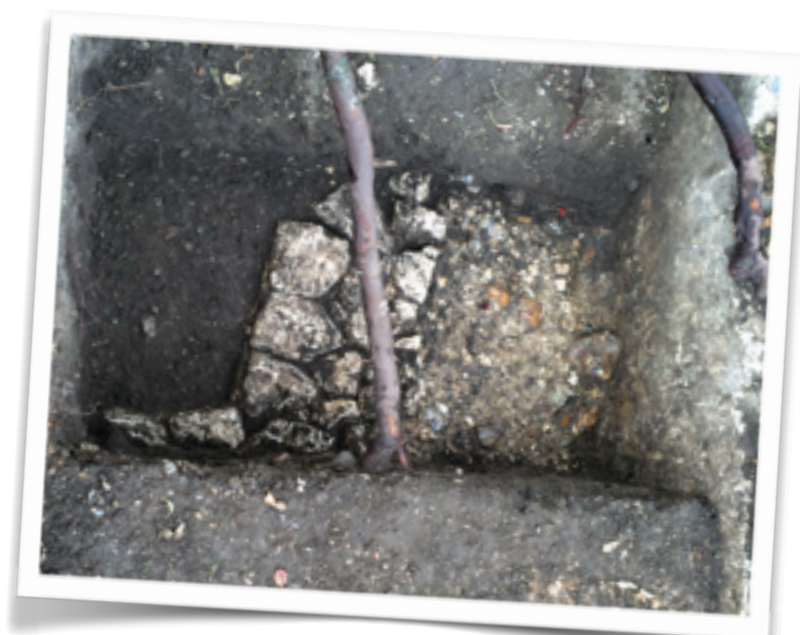
Chalk blocks of a tomb in Trench C

The double tomb was uncovered to the south of the northern nave wall. It was below the level of the Norman floor and constructed of chalk blocks laid regularly to build two chambers with a thin dividing wall. In addition a second tomb was discovered in this trench which was not previously recorded by Bedwin. This tomb was located directly to the south of the double tomb and was constructed in the same manner using

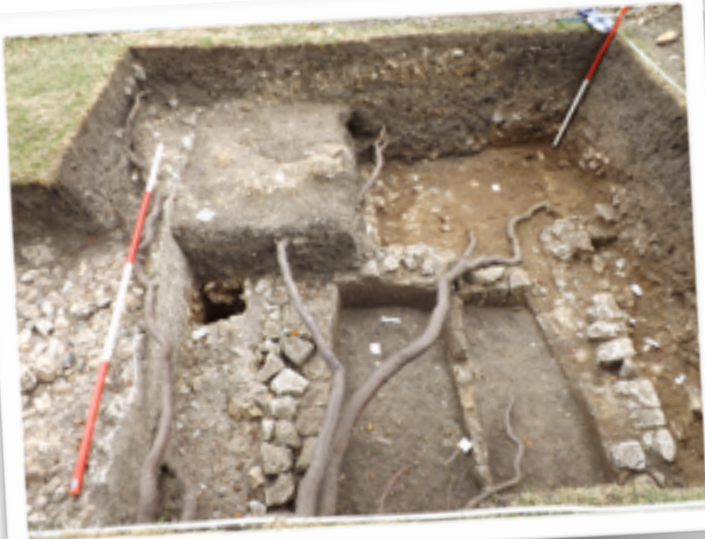
The double tomb uncovered in Trench C.

shaped chalk blocks. Bedwin's 1974 trench edge was found during the excavation and demonstrates that his dig would have only seen the double tomb and a few blocks of the next tomb, which could have easily been taken as part of the double tomb wall. The southern tomb would have been constructed at a later date than the double tomb found by Bedwin's team, as it clearly cuts through the double tombs southern most wall.

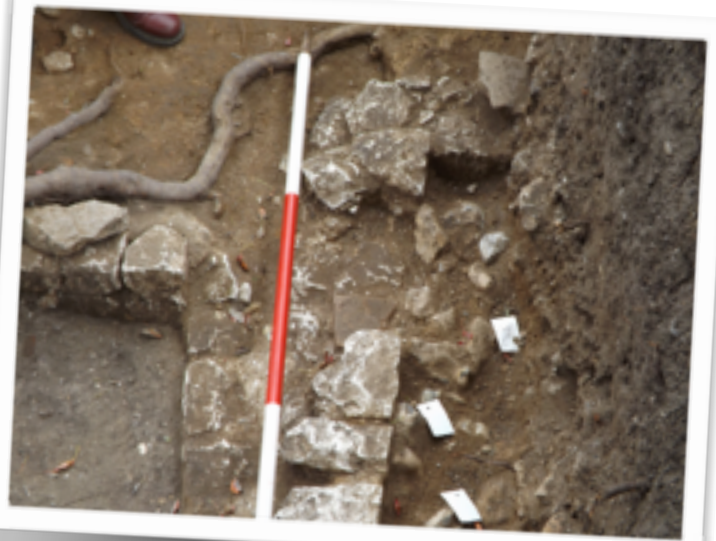
The southern tomb cutting the double tomb - Trench C

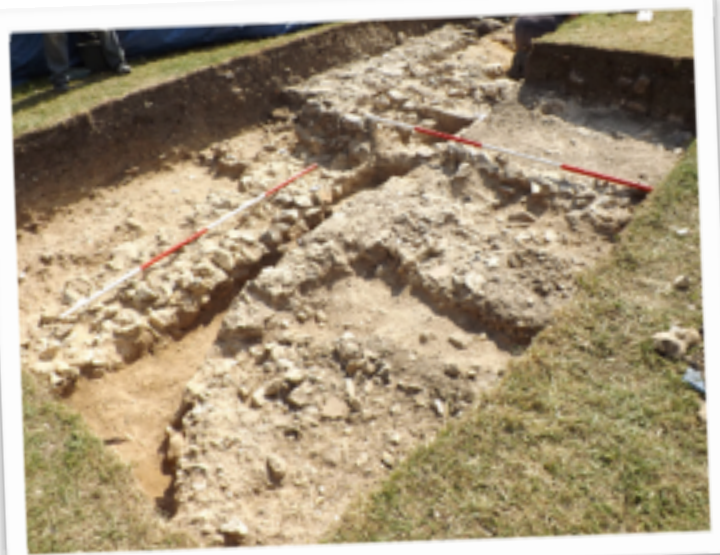
The Norman and Saxon chancel walls - Trench D

This was the trench which changed almost daily throughout the excavation. The original trench layout was dug to a depth of 96cm and revealed the southern wall of the Norman nave and the outline of the Norman chancel wall. Within these walls the excavations uncovered a very well preserved masonry floor level which included a clear imprint of a large flagstone shaped tile. To the south of this level a dressed-stone lined hole was uncovered which was thought to be the remains of the piscina. To the west of the masonry floor was a small partition wall leading to a coarser

rubble layer which would appear to have been a level for another of floor. Beneath this level the smaller masonry blocks of the Saxon chancel wall were found curving away from the straight Norman chancel. It was between these two phases of the chancel that the skeletal remains of an infant were found. The individual was tiny and the bones incredibly fragile. From the arch of the skull the baby would appear to have been full term or very close to, possibly a still born. The child had been placed with care but within a rubble layer. This would suggest that the child had been laid to rest at some time during the building work which redeveloped the chancel of the church during the Norman period, something which may not have been officially allowed.

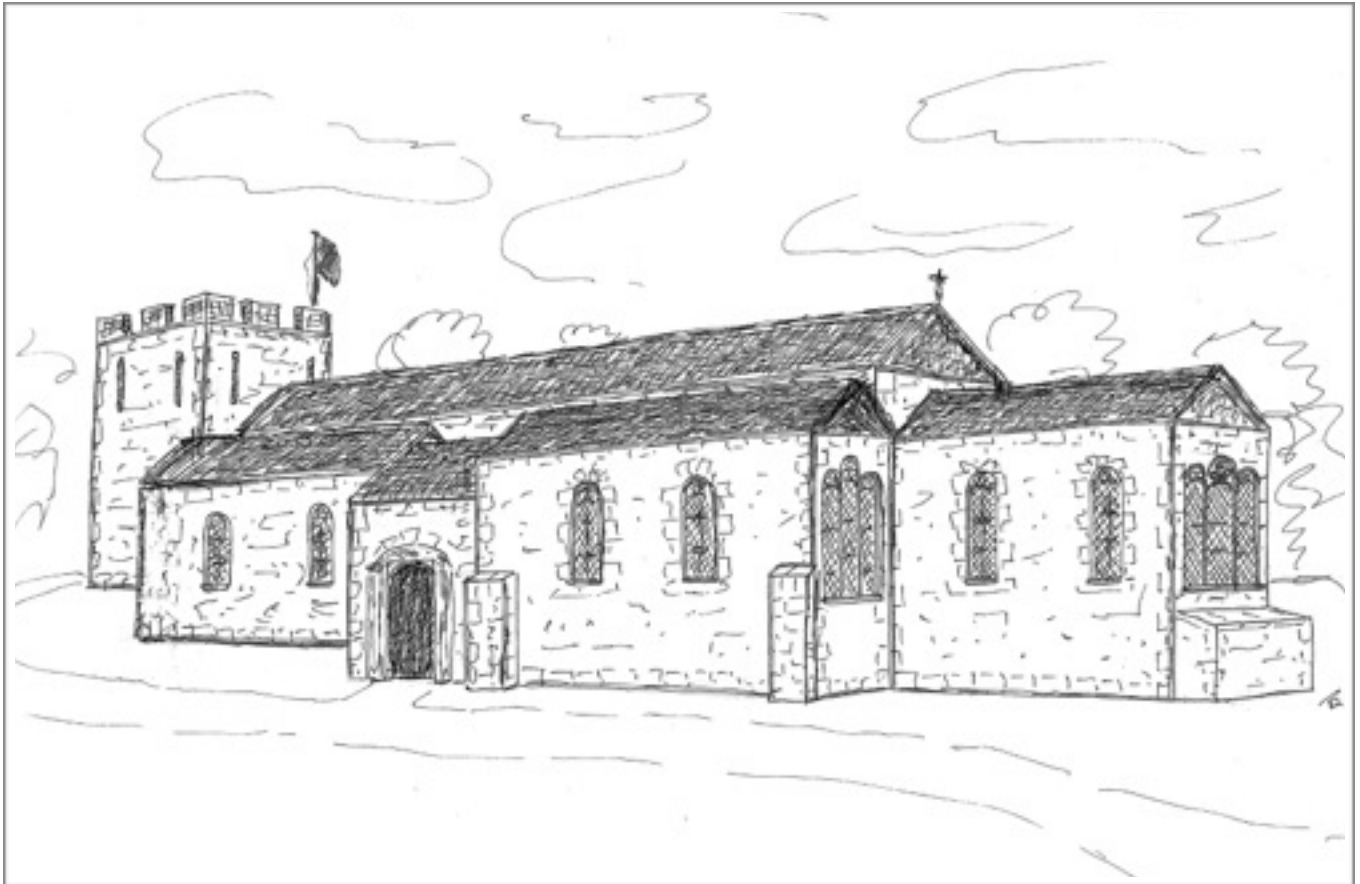
2015 Interpretation of St Nicholas' Church - © Bob Turner

Overall the 2015 excavation at St Nicholas Gardens was very successful. The team began the dig in early June with clear objectives, all of which were achieved, and are now written up in the full archaeological report. Primarily the excavation was able to clearly establish the footprint of the medieval church, a project begun by Bedwin and extended by WAS along with the Angmering community. The anomalies spotted on the geophysical survey were also investigated and resolved. However the truly exciting aspect of the project is WAS's ability to now add to the work carried out by Bedwin. In 1974 the southern side of the Norman and Saxon chancel was only extrapolated using the walls excavated to the north. The relationship between these walls always seemed a little usual and now the 2015 team can draw in the true construction lines for this section of the church. Similarly the excavation of trenches A and B have resulted in a new interpretation of the tower. As the above drawing demonstrates the tower is now thought to have been located on the west side of the church as is more usual for this type of building. The walls in trench A were much more substantial and include extra supports which would be needed in an elevated structured

positioned on a sloping gradient. In contrast it was agreed that the walls in trench B were not what would have been expected to support a tower structure, and its position on the southern side of the church, at the lowest point of the site gradient made it an unlikely position to choose when constructing a key element such as a tower.

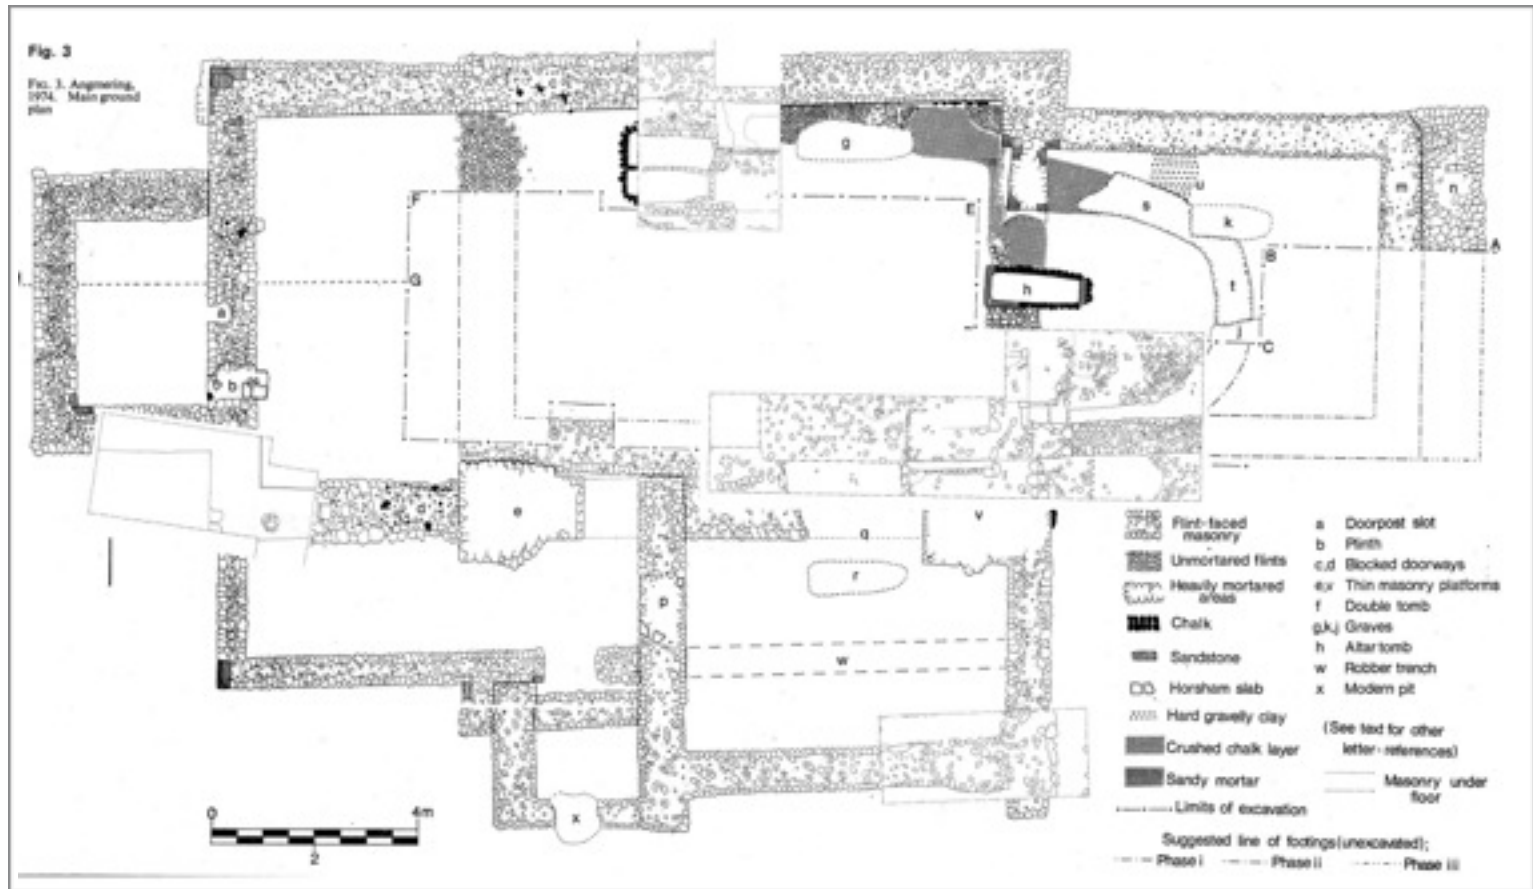
2015 Trenches overlaying Bedwin 1974 Excavation Plan

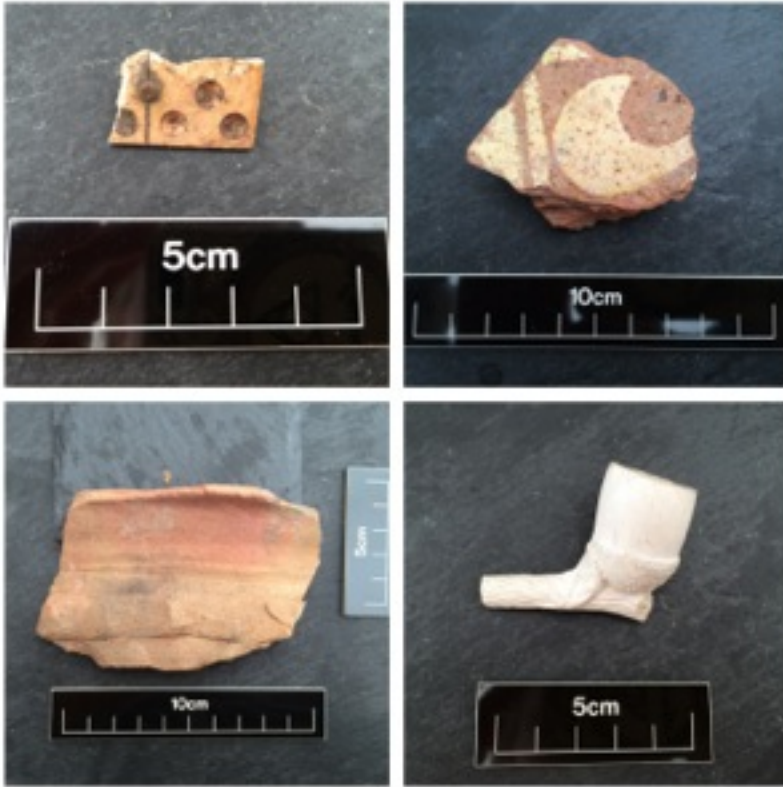
A small selection of the Finds

Throughout the dig the finds team were kept busy with a constant stream of artefacts arriving at the tent from across the site. Due to the Bedwin excavation in 1974 few of the finds were recovered from undisturbed contexts, but there was great variety in terms of their type and age. The finds team were able to identify pottery shards from the 12/13th century through to modern times, pieces of metal work, such as a small cross and a lovely horse shoe shaped button, coins from many periods, including one from the reign of Edward I, painted wall plaster, stained glass and lots and lots of clay pipes.

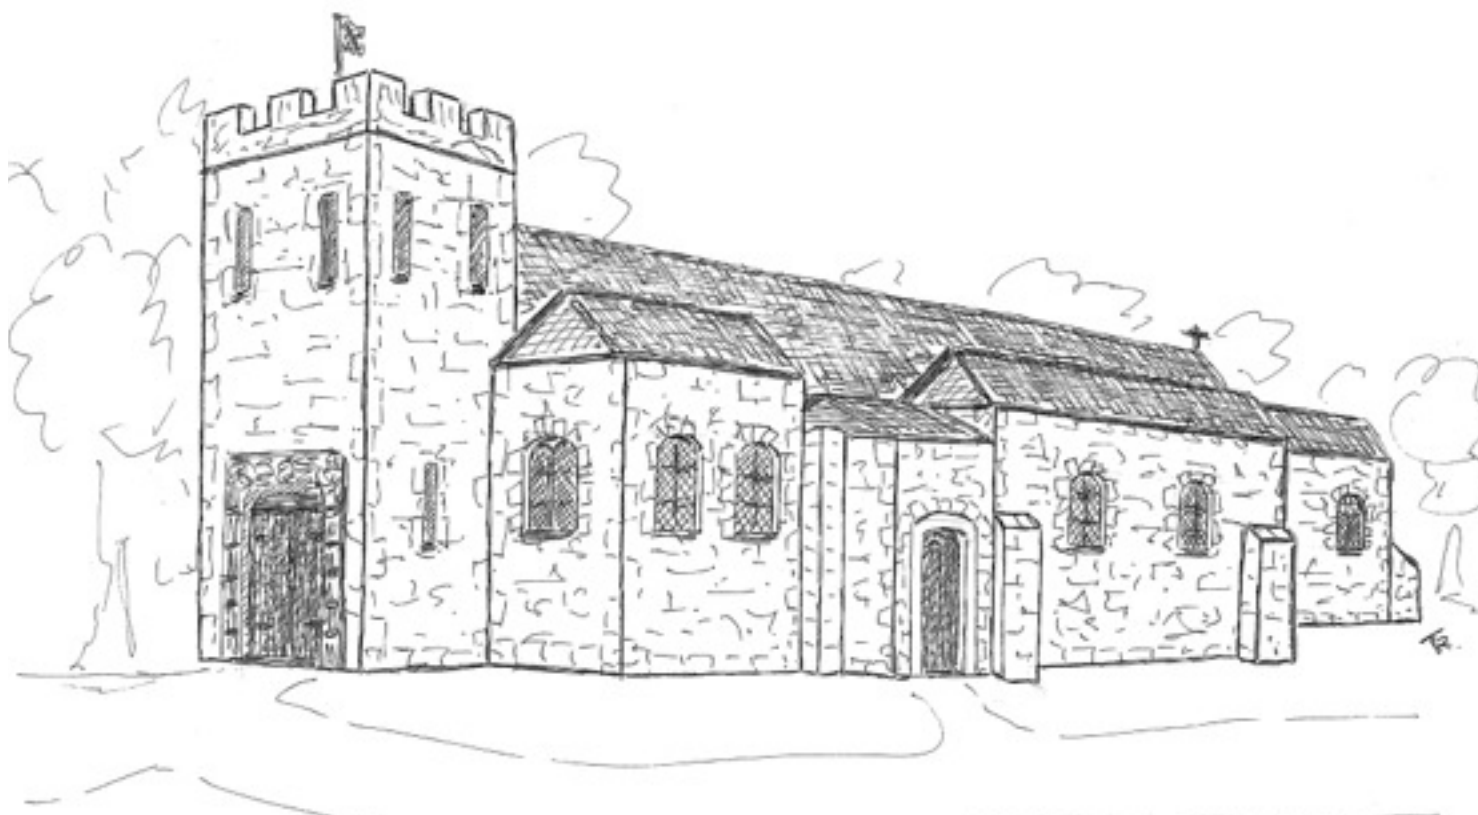
St Nicholas' Church following the 2015 excavation - © Bob Turner

The Angmering excavation of 2015 was a true success, with all objectives being met and the community involvement being fantastic. Archaeologically the WAS team were able to identify the layout of St Nicholas' Church in relation to Bedwin's 1974 excavation and to further define areas such as the southern nave including the phases of its construction. In addition WAS extended the dig to examine the possible feature observed on the geophysical survey resolving the anomaly, even though it turned out to be fairly modern in origin. Lastly the excavation demonstrated that the tower feature of the Norman church would once

have stood to the west of the site instead of the south something which can be observed in similar churches such as St Margaret's which stands just over the modern road to the west of the gardens.
