# Worthing Archaeological Society Journal

Volume 5 Number 4  
December 2021

# The Romano Celtic Temple on Lancing Down

## EXCAVATIONS AT LANCING DOWN, WEST SUSSEX 1980

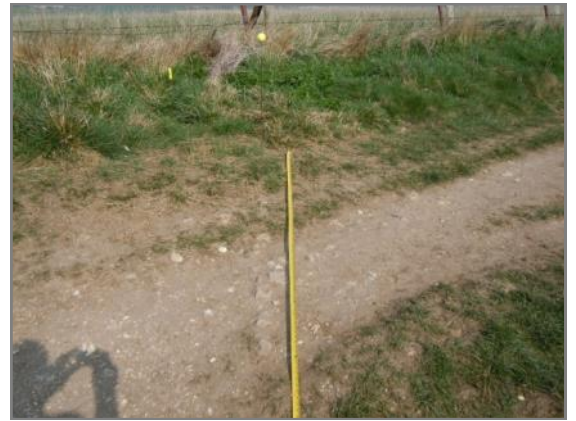
*Figure 3 North outer wall*

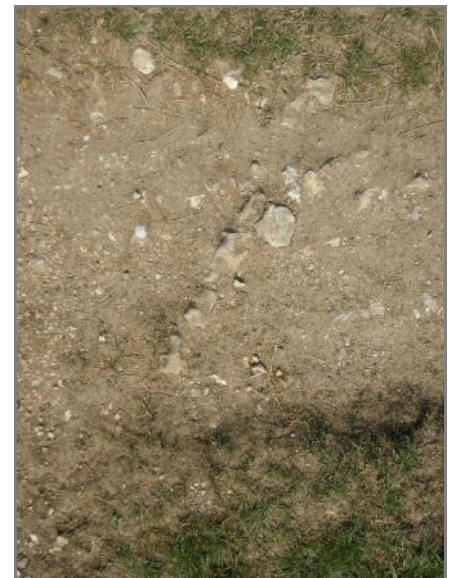
*Figure 4 North outer close up*

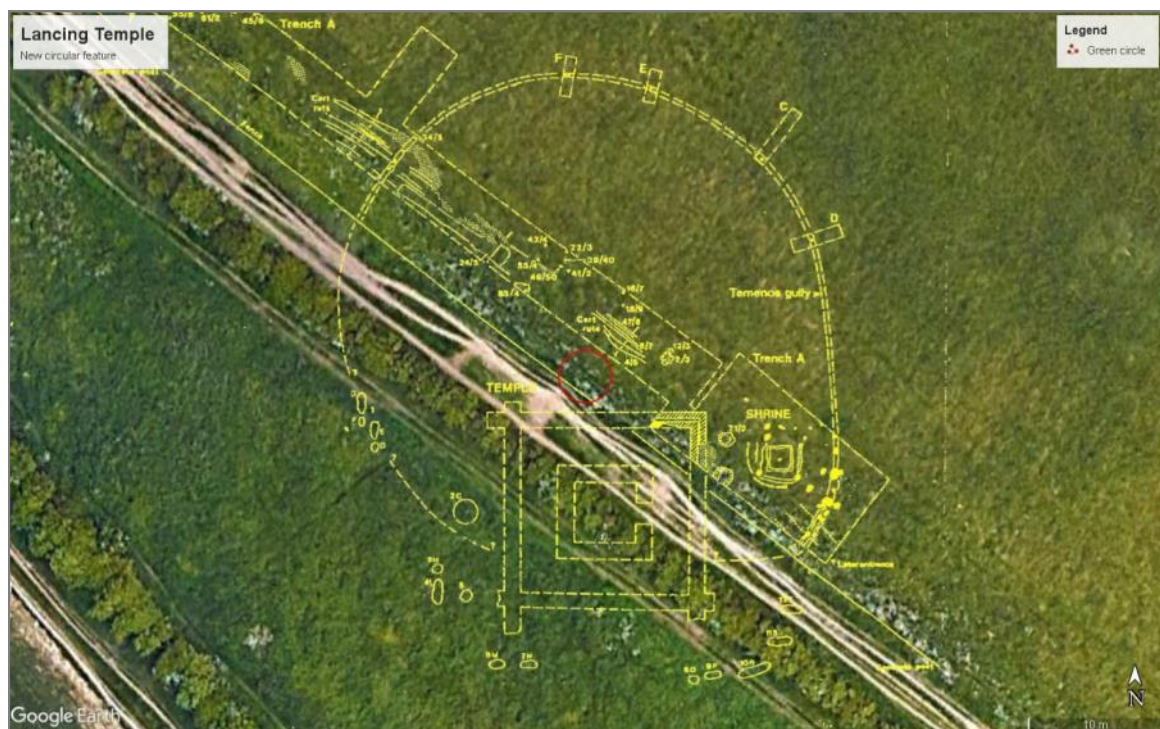
Another site visit in July 2018 revealed a circular patch of vegetation that is noticeably greener than its surroundings. This patch is located just South of the 1980 trench and is believed to be North of the area excavated by Medhurst. The location and size are indicated by a red circle in Figure 6 below.

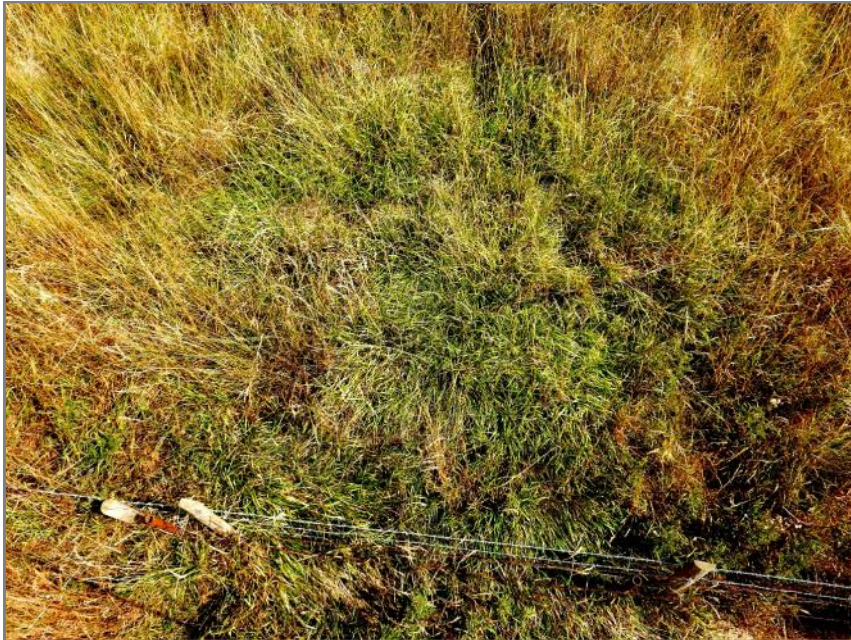
Figure 7

A photo of the green patch which is about 4m in diameter is included below as Figure 7. This feature was not identified on the 1830 drawing but a circular 'bath' was referred to outside the West facing outer wall: *'A bath lined with hewn chalk, two feet deep, and four feet and a half in diameter.'*

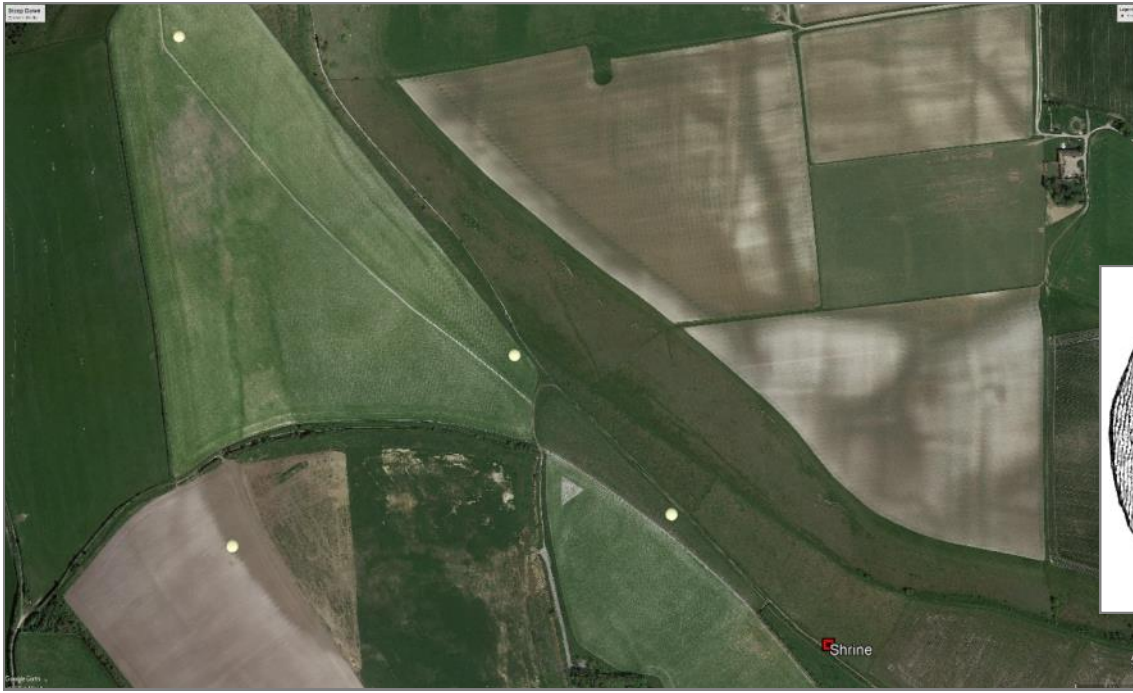
Figure 8

These survey notes were used by the author to mark the barrow locations on Google Earth and the result is shown below in Figure 8.

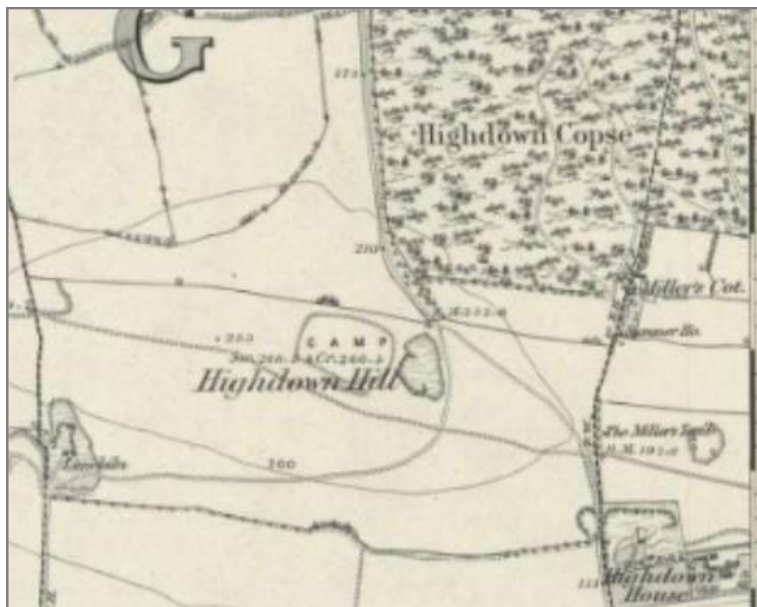
Figure 2 Highdown Hill: OS Sussex XLIX Surveyed 1875/6 pub. 1880  
National Library of Scotland viewed 8/11/21

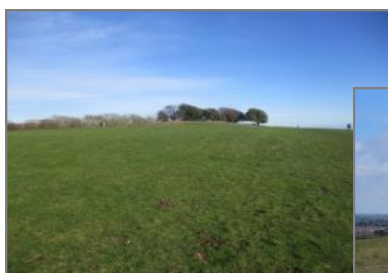
Figure 3 Possible site of  
Roman watchtower or signal  
station at the southern end  
of Highdown Iron Age hillfort.  
Photo: Alex Vincent

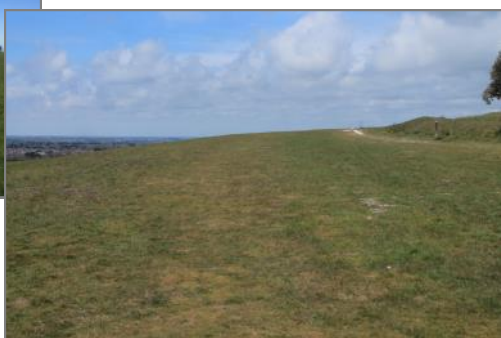
Figure 4 Possible site of Roman watchtower  
or signal station at the western end of the  
hillfort, Highdown.  
Photo: Alex Vincent.

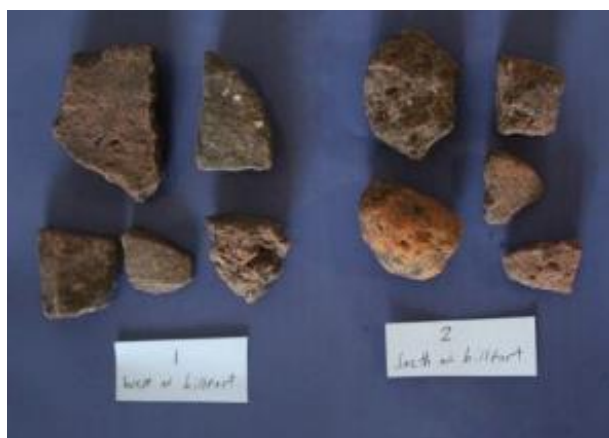
Figure 5 Brick and tile from the sites, which could be Roman.  
1 West of the hillfort and 2 South of the hillfort.  
Photo: Alex Vincent

Just west of the hillfort is a square earthwork, which may have been re-used as a signal station or watchtower instead. The author has found brick and tile on both sites, which has been confirmed as probably Roman and/or medieval in date. Field walking and excavations hopefully will be carried out at these sites in the future.

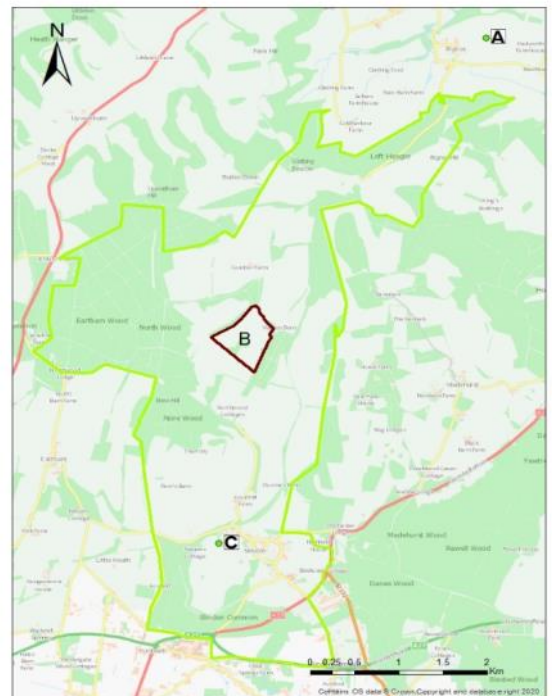
The site (see B in figure 1 below) is centred on NGR SU 496000 111075 and slopes from 110m OD in the North East to 95m OD in the South West corner of the field. The field is located to the South-West of Warren Barn. The solid geology is a mix of Newhaven and Seaford chalk.

*Figure 1 Slindon Estate Map showing key Romano-British sites*

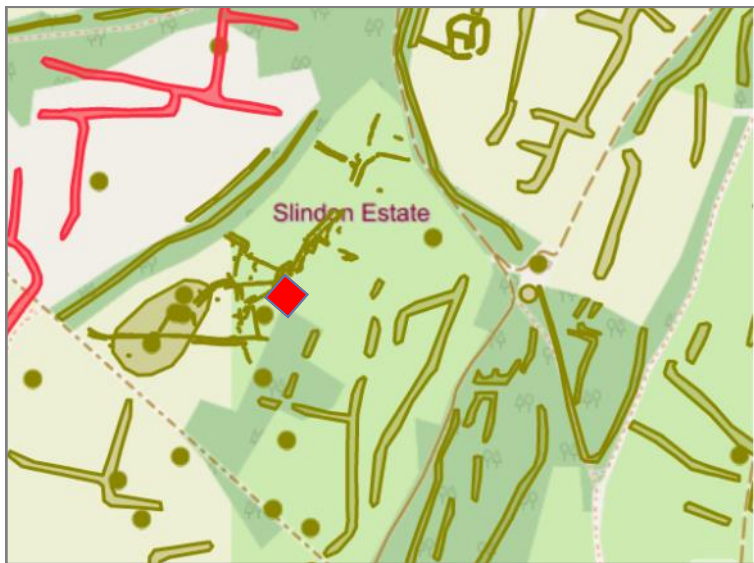
There are a number of field systems in the vicinity of the War Ag 2 site, which are probably Iron Age or Roman. Figure 2 below shows the field systems identified through the lidar data as part of the Secrets of the High Woods project. The War Ag 2 site is shown by the red diamond.

Figure 2 IA and Roman Field Systems from NT record 121031

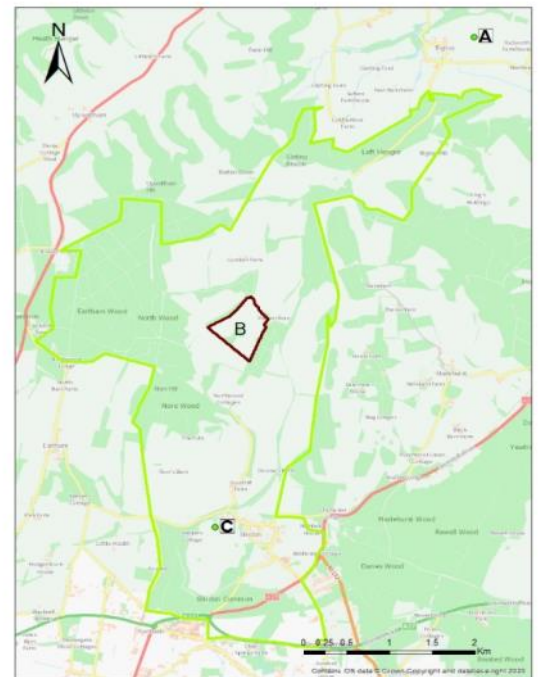
The main Roman feature on the Slindon estate is Stane Street, which runs SW to NE through the Gumber area of the estate. Whilst not on the estate, the lands belonging to and supporting the Romano-British villa at Bignor (see A in figure 3 below) probably extended over the Downs into the Gumber area. The third Romano-British site located on the Slindon estate, is an aisled-barn located in the grounds of the medieval deer park (see C in figure 3 below). The evidence from the barn suggests a fixed use of human habitation together with a working area suggested by burning and possible foundations of a grain dryer.

Figure 3 Slindon estate map showing key Romano-British sites

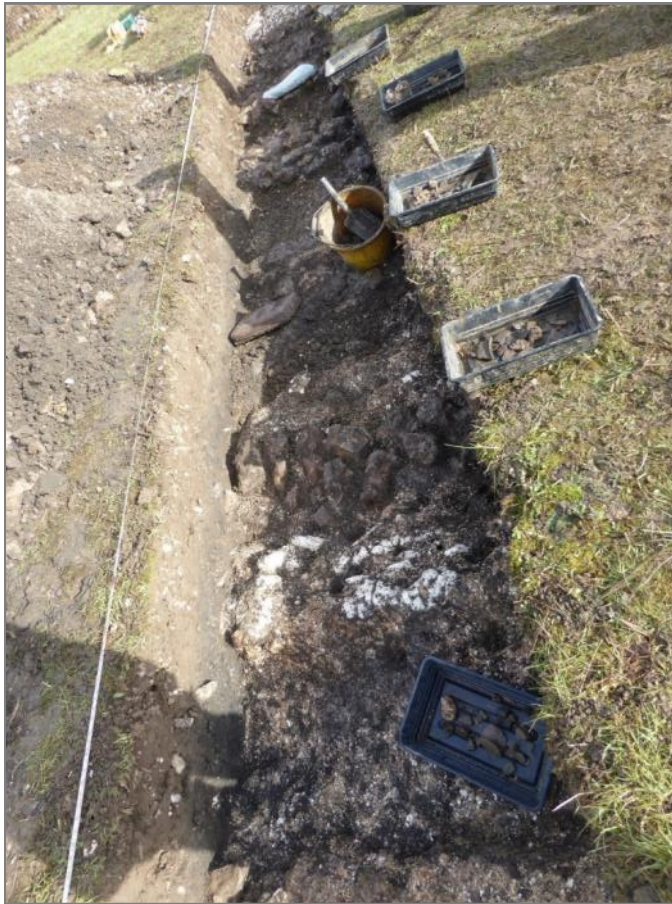
*Figure 5 2016 Excavation 'Long' Trench*

Following on from this geophysical survey, a series of evaluation trenches were excavated in February 2016 by West Sussex Archaeology (WSA). Of particular interest were two features uncovered during this excavation; an area of burning and a series of linear features consisting of large pieces of flint (WSA, 2016). See figure 5 below for the linear features consisting of chalk and flint.

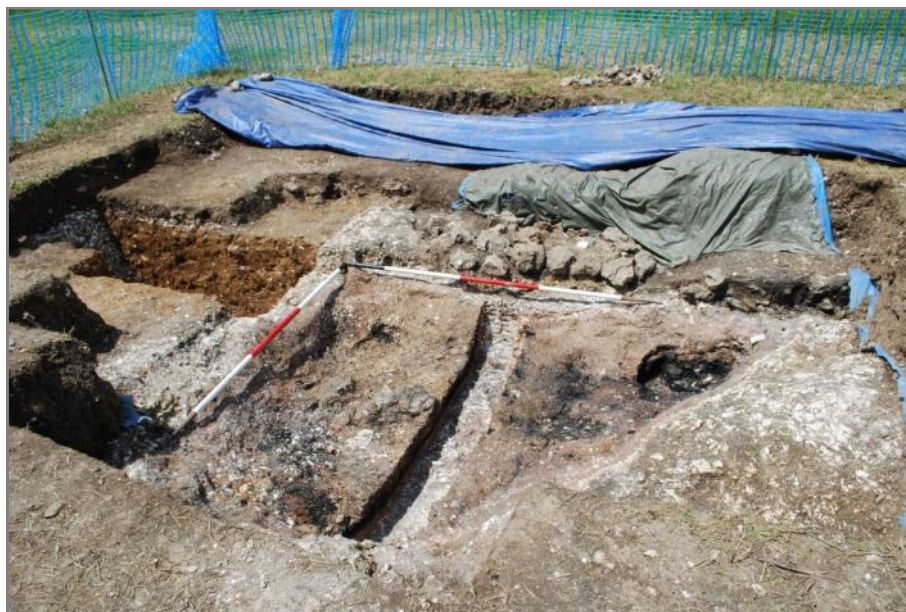
Subsequently, Worthing Archaeological Society Field Unit (WASFU) undertook two sets of excavation (2017 and 2018) to examine the above two features. In addition to excavating these features, the 2017-18 excavations located a series of ditches and a clay lined hollow. The 2018 excavation revealed that the clay lined 'lozenge' was in fact triangular, with a ditch to the south of it noticeable by its reddish-brown fill (see figure 6 below).

*Figure 6 Trench 2 from 2018 Excavation showing ditch to the top left and clay lined feature in centre of picture*

The thick clay lining of the key feature (No. 10) indicates that this was able to retain water – whether as part of an industrial process such as preparing grain for malting or for use with animals is impossible to tell. It is worth noting that there is a 60mm layer of burnt soil on top of the clay. This layer is associated with the feature's function or was deposited after the feature went out of use. Of the two options, the second is more feasible.

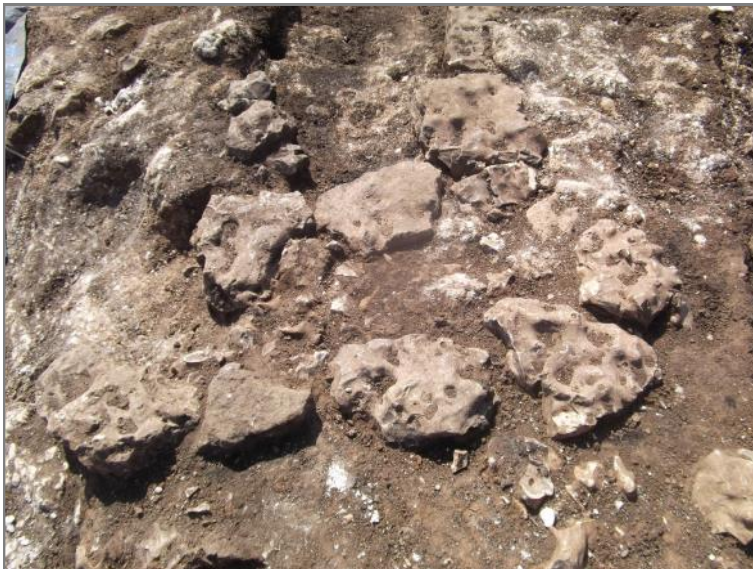
Figure 7 Curved End of Feature No 1

It is conceivable that they supported a flimsy or temporary structure. The amount of burnt material could suggest a series of grain dryers, but apart from the northern end of features (No. 1 and 2) there are no cross-walls/foundations and no obvious evidence of stoke-holes. See figure 7 below for end of feature No 1. So, whilst these structures may not be the remains of grain dryers, the ten quern stone fragments found suggests that cereal was processed in the vicinity.

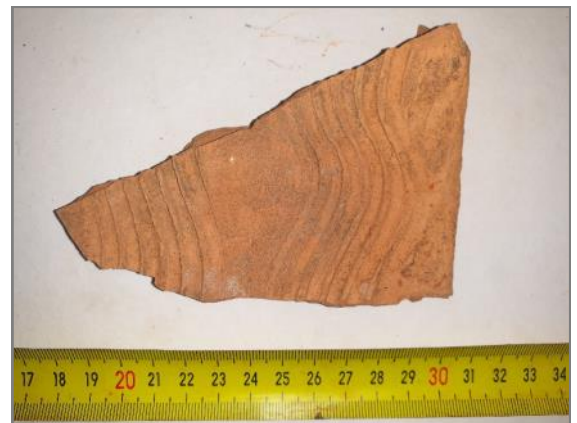
Figure 8 Combed tile found in field 20

Whilst the location of this site half-way up the Downs suggests that this is a low status establishment (Rudling 2003, 115), the presence of three pieces of combed tile (see figure 8 below) from the Upton Collection, which was collected in the same field, could imply that a more impressive residence is nearby and is awaiting discovery.

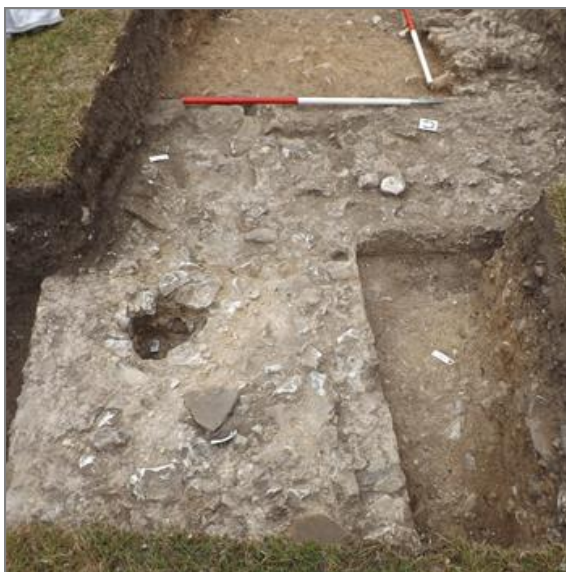
In Trench A, three intersecting structural walls were found, all constructed of flints placed within mortar. These wall lines are seen on Bedwin's original excavation map and are listed by him as being the south wall of the porch and part of the Norman nave. Each of these sections of masonry wall was integrated into each other, which would suggest that they were all part of one phase of the church's development.

*The walls discovered in Trench A*

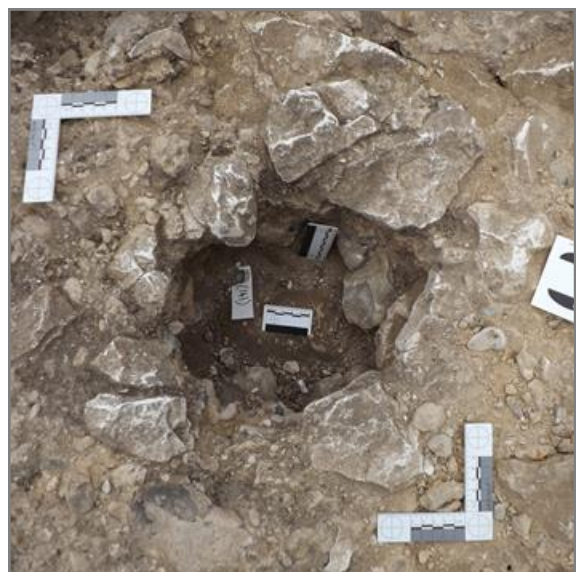
A small hole was also uncovered within one of the walls. This was not mentioned in Bedwin's excavation report. The hole was built into the wall, rather than having been made due to some form of destruction, and was likely the foundation for a structural post included within the wall itself. Internal wall posts can be used as part of structures built on slopes, to give the wall extra support, particularly if the wall is a crucial load bearer. Small fragments of white plaster were also recovered from this trench, indicating that the church would have once been decorated.

*Stone post hole found in Trench A wall*

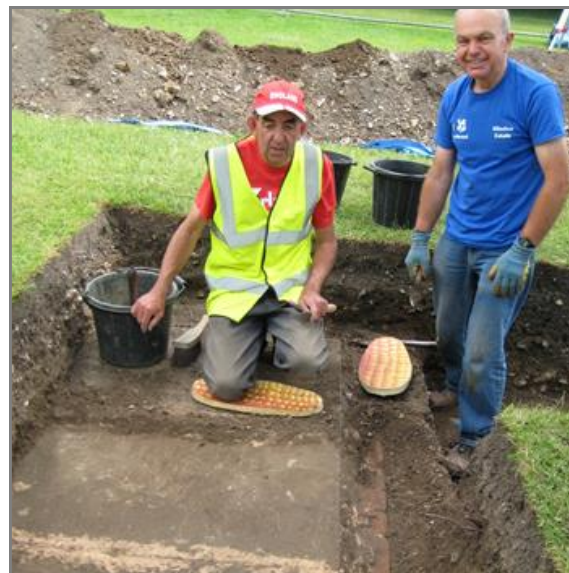
The second objective of this trench was however less successful. The L-shaped trench was designed to investigate the anomalies identified from the geophysical survey. These anomalies were quickly identified. But they were in no way medieval. As the first curves of the trench were lifted, the top of the anomaly, a large drainage system with an accompanying water chamber, could clearly be seen. For the rest of the excavation it amused the children to hear we had found part of an old toilet system.

*Finding a modern drainage system*

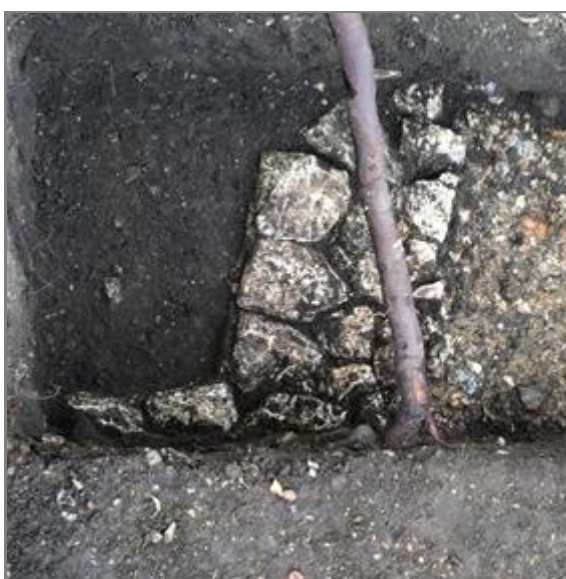
In Trench C the northern wall of the church was quickly found, with fine white plaster on the face of the wall. In 1974, a double grave was discovered in this area, however no sign of this feature could be found, at the expected depth, in 2015. As the plaster on the wall seemed to be continuing it was decided to excavate a little further down, to see how far it extended. This turned out to be a very good decision as it was in this small sondage that the double grave first appeared. As the area was excavated the grave was fully uncovered along with the remains of a

*The first sign of the double grave in Trench C*

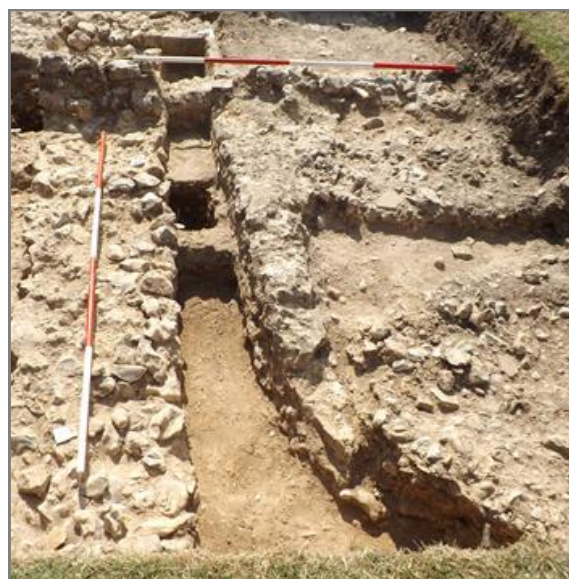
The final trench of the excavation was Trench D. Archaeologically this was possibly the most interesting of the four trenches. The trench revealed the southern wall of the Norman nave and the outline of the Norman chancel wall. Within these walls the excavation uncovered a very well-preserved masonry floor, which included a clear imprint of a large flagstone-shaped tile. To the south of this level a dressed-stone lined hole was uncovered, which was thought to be the remains of the piscina. To the west of the masonry floor, was a small partition wall leading to a coarser rubble layer, which appeared to have been a level for another floor. Beneath this level the smaller masonry blocks of the Saxon chancel wall were found, curving away from the straight Norman wall. This categorically explained the relationship between the two phases of church construction.

*Trench D - Both Saxon and Norman chancel walls*
