# Worthing Archaeological Society Journal

Volume 4 Number 2  
January 2015

# Slindon House Stable Block, 2012/13

**A report on the clearance of the Slindon House Stable Block** (See Appendix 3, page 14 for figures/photographs)

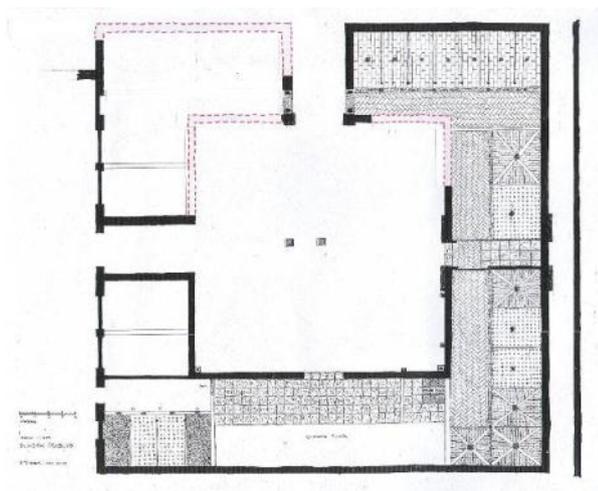
*Plan of Slindon Stable Block (red lines indicate areas that are covered or missing but are added on the assumption that the building was symmetrical)*

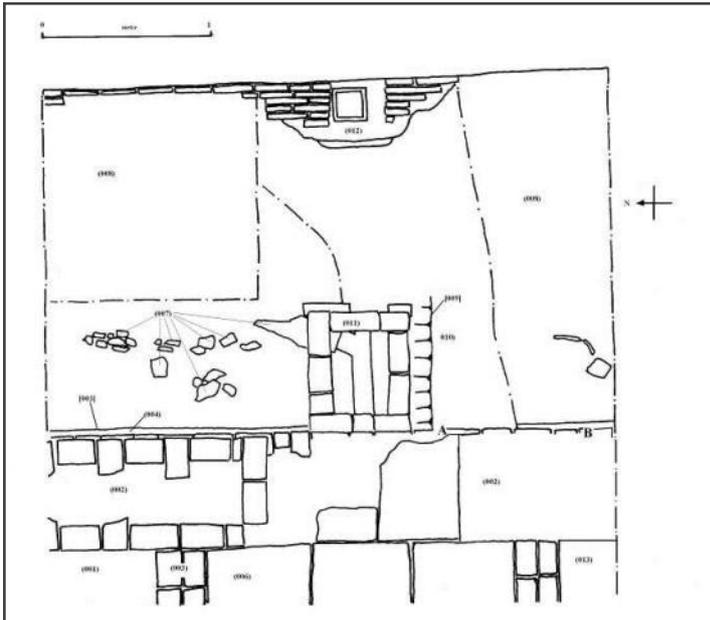
Figure 1. Plan of trench. The line of section was drawn along A—B.

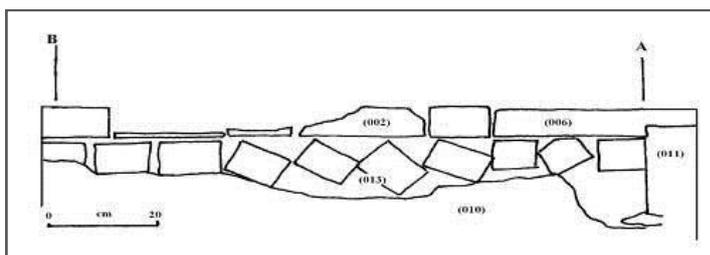
Figure 2. Section to show depth of the foundation

In the area excavated the foundations extend to a maximum depth of 17cm, being founded on solid chalk. They are essentially a leveling feature (composed of brick in mortar) on which the wall was constructed.

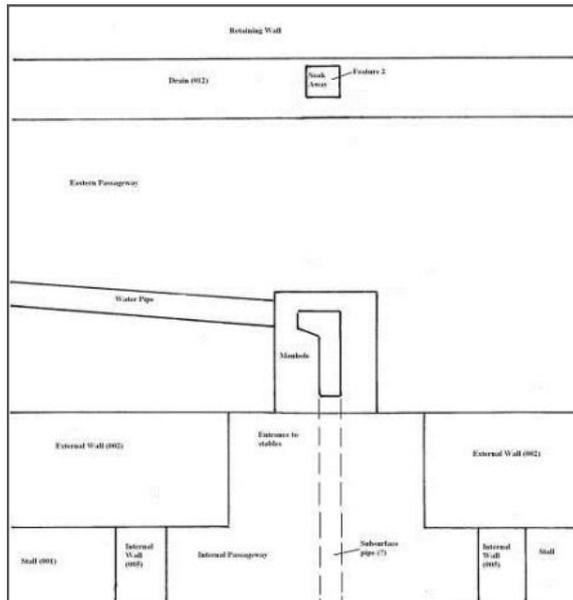
Figure 4. Interpretation of figures seen in trench 1

Prior to the excavation it was assumed that feature 2 (see Figure 4, an interpretation of the features seen in trench 1), the drain attached to the eastern retaining wall, would link up with the drain that runs beneath the internal corridor.

However, there is no subsurface connection between the two features and we currently think that feature 2 lead to a soak away. It, and the associated brick built drain, appear to have been added to the eastern retaining wall, almost certainly to cope with a drainage problem that arose after the construction of the stables.

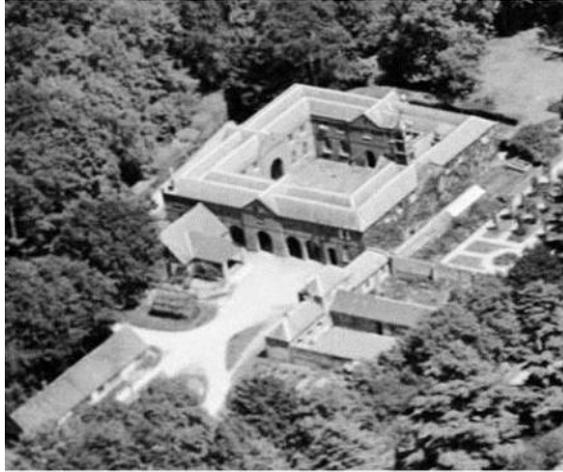
*Figure 1. Aerial View of Slindon House Stable Block, photographed in 1935*

The stable block sat on the lower slopes of the chalk hill on which Slindon House is built. We are fortunate that aerial photographs from 1935 exist, which show the plan of the building before its destruction. (fig.1) There are also a few photographs that show the exterior of the building. (fig.3) These confirm what emerged from our clearance, namely, that the stable block was a square, largely symmetrical building 150 ft square,\* of two storeys with a central quadrangle. From the photographs we know that the slated roof was of two spans with leaded valleys and boxed gutters. On the outside the roof overhung the walls but in the courtyard the roof was faced by a parapet with stone coping. The walls were built of bricks laid in Flemish bond with burnt headers.

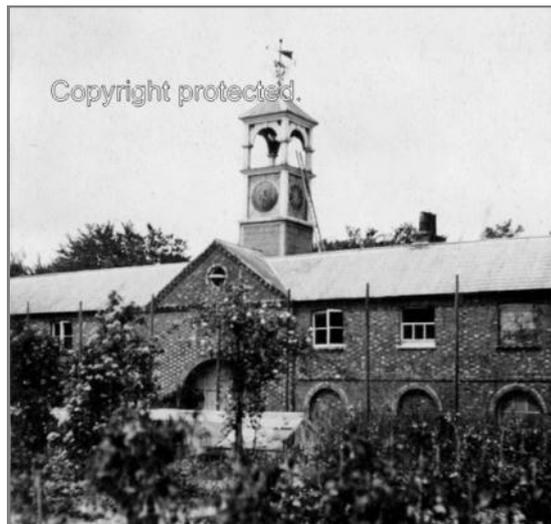
*Figure 3. South Wing and Clock Tower*

Above the South Wing was a clock and bell tower. This appears to have been a substantial wooden structure in three sections. The lower part was faced with slates; the centre section was lead

faced with clock dials on at least two elevations and glazed panels on the other sides. Above the clocks was an open section for the bell and lever arm and the whole was topped by a hipped slate roof with an ornamental weather vane.

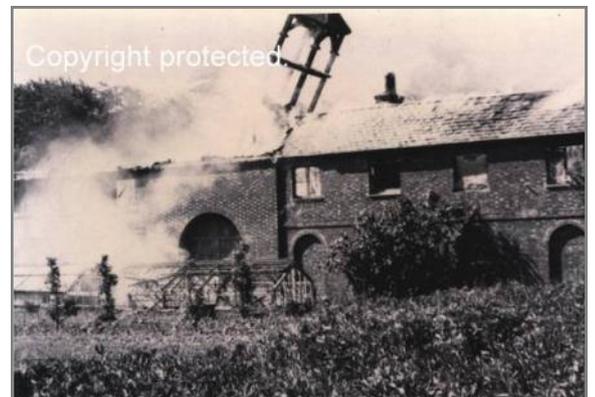
*Figure 4. The clock tower collapses as fire takes hold of the building*

The stable block was struck by fire in the 1960s. (fig.4) There is surprisingly little local memory of this event although there are several photographs. So far no newspaper account has surfaced so these photos provide the best clues to what happened. It seems that prior to the fire the whole building had fallen into disrepair. Perhaps it never recovered from its wartime use. It was apparently used for keeping pigs and for the storage of hay and feeds. The story is that school-boys from the adjacent school were in the habit of using one of the upper rooms as a smoking den and it is easy to imagine how the disaster developed. The photographs of the fire only show the southern wing but it was plainly well alight, sufficient to burn through the heavy timbers supporting the clock tower. The photographs do not show any fire-fighting activity, maybe the building by this time was so poorly esteemed that it was allowed to burn. Plainly, the debris was later removed down to ground level and the space was reused as a yard.

Photographs of the fire that destroyed the stable block show that it was fiercest in the area of the clock tower, which was above the central arch. During clearance we found burned material in this area with melted lead and thick pieces of glass. The flagstones here are darkened from burning. This cannot be confirmed as evidence of the fire however because the Trust frequently have large bonfires in the courtyard.

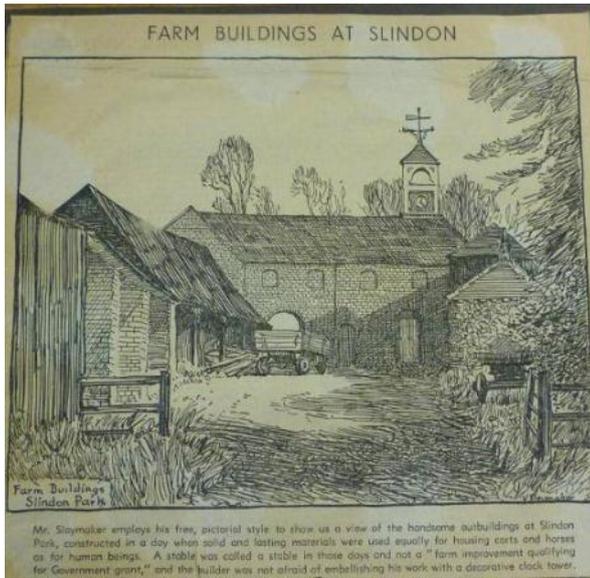
Figure 5. The West Wing, from a sketch published in the newspaper c.1930 by Mr. V. Slaymaker

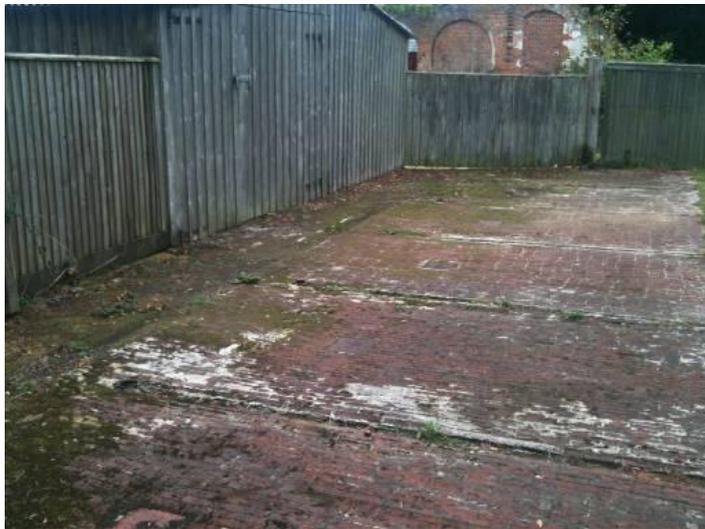
Figure 6. Brick forecourt, old North Wing, showing stable floors and drains

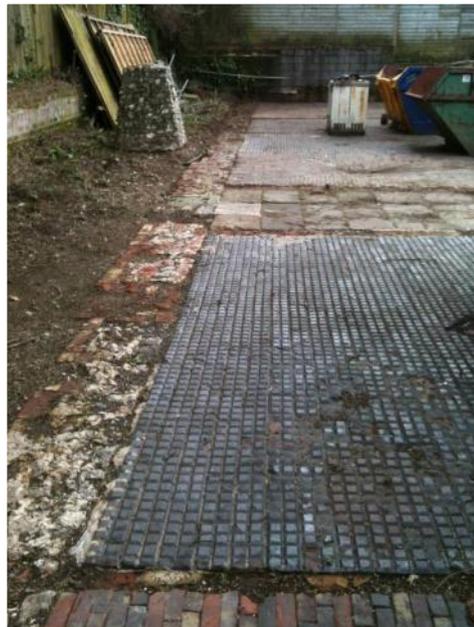
Figure 7. Floors of stables, passageway and loose boxes on East Wing, and foundations of outer wall

Midway along this range there is a brief change of surface to flag stones. (fig.7) Many of these are broken and laminating but one or two are sufficiently intact to show that they were once thick stones about 18ins x 12ins. They run through the wing from the outside towards the courtyard where a substantial threshold is still in place, creating a narrow passageway. This flagged passage corresponds to the archway that can be seen in the photographs. The passage way is crossed by the herringbone corridor which runs the whole length of this wing. There is a slight evidence of thresholds where the corridor crosses the passage, suggesting that there were doorways opening both north and south, giving access into the corridor. This fits with the layout of surviving stable blocks elsewhere. Going south, the corridor stops at the last loose box which makes the corner with the South Wing.

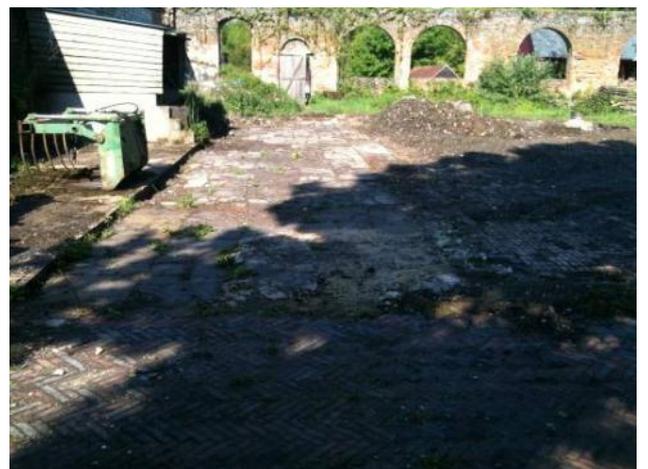
Figure 8. Flagstones of the coach house floor on the South Wing

South Wing The floor of the South Wing is completely different. For three quarters of the length it is surfaced with large flagstones. (fig.8) Most of these are now laminating and some are broken but it is easy to see that this was once a substantial and impressive floor. It was probably the coach house and we know from photographs that there were heavy wooden doors on both elevations that would have allowed passage both into and through the wing. There is one exception to this spread; at the start of the flags, against the inner wall of the courtyard, is a patch of thick mortar about 4ft x 6ft laid on top of the flags. This is probably the hearth for a fireplace; one is mentioned in the War Ministry Schedule and this is probably therefore the location of the saddle room which was traditionally the domain of the head groom and usually quite snug. A couple of feet away in the courtyard is a shallow drain gully, often found where a pipe empties through a wall.

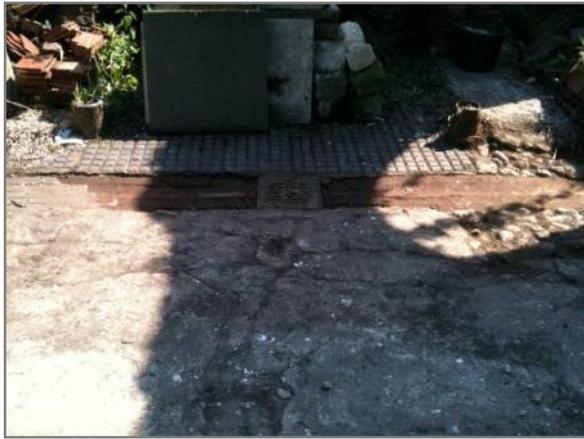
*Figure 9. South west corner showing chocolate block pavers, cobbles and stanchions*

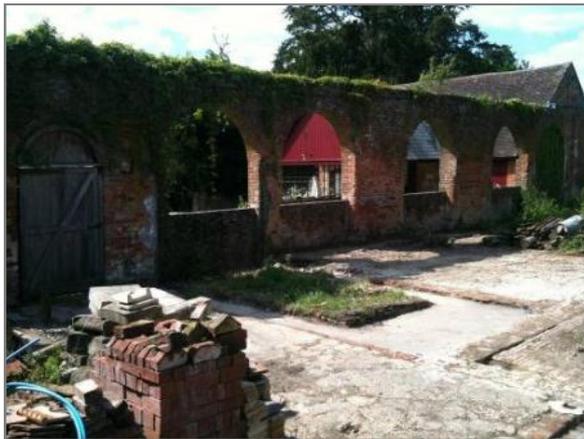
*Figure 10. The brick arches of the west wall showing concrete floors and partition walls*

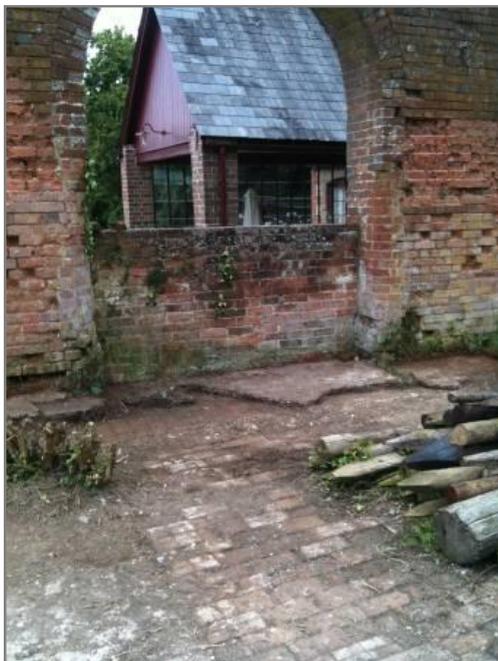
*Figure 11. Paved driveway from blocked up central arch, showing chamfered piers, concrete overlay and the trench carrying modern services*

The floors at the southern end of this wing have been concreted over, more than once, and there is a series of post holes about a foot away from the line of the inner, courtyard, wall. These look as if they might have supported a fence or partition and probably relate to some repurposing of the space after the fire. They would not make sense if the inner wall was still in place. Nearer the arches the floors have been broken by a service trench but there is no evidence of the brick floors present in the other wings. There are at least four internal walls running at right angles to the arches and it seems that each arch opened to a room behind. Some of the arches have the pins for gate hinges or doors. Because of the concreting it is not clear whether there were any connecting doors between the rooms. The pillars of the three central arches have chamfered brickwork which would ease the passage of vehicles so we can assume that these rooms were used to store carts, traps and waggons and perhaps, from the early twentieth century, motor cars. The main yard surface continues as a drive for the width of the centre arch. (fig.11)

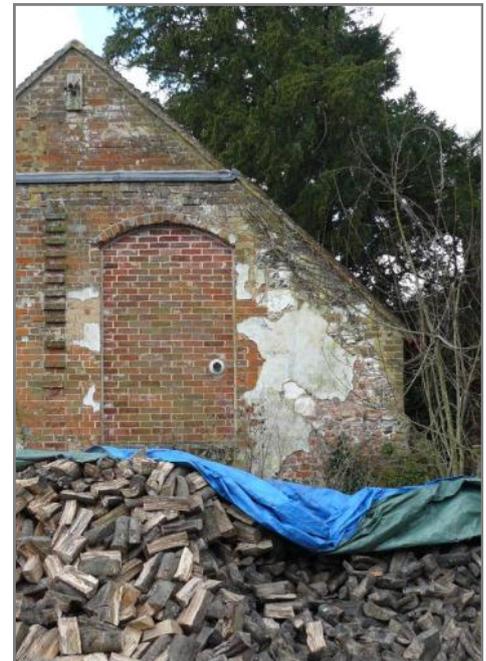
*Figure 12. Irregular build of north west corner at end of arcade*

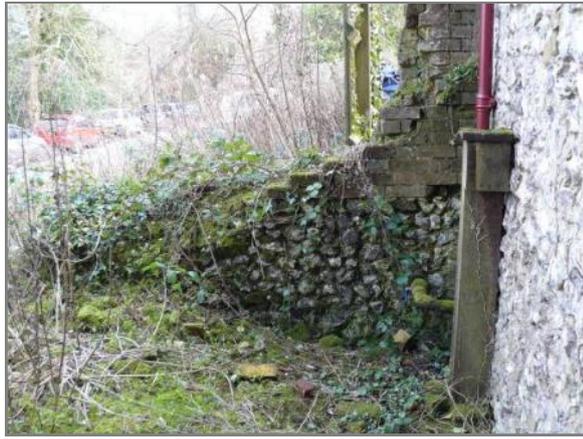
Figure 13. End of the west wall abutting NT office

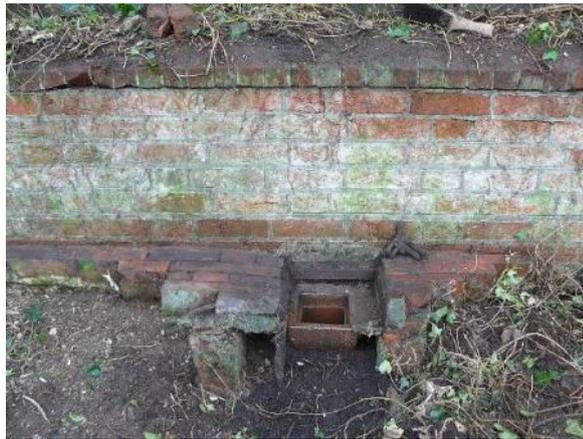
Figure 14. Retaining wall, brick channel and gully on the east boundary of the site

The gully is directly opposite the pedestrian entrance on that wing and immediately outside the threshold is a square drain with a grid. This, in turn, lines up with the central drain in the courtyard, leading us to suppose that the gully connected to the main drainage scheme. We sought permission to investigate this further with a proper excavation of the drain (see appendix 1) but found what appeared to be a supply pipe. If the gully connects to the courtyard drain it must do so at a much deeper level.

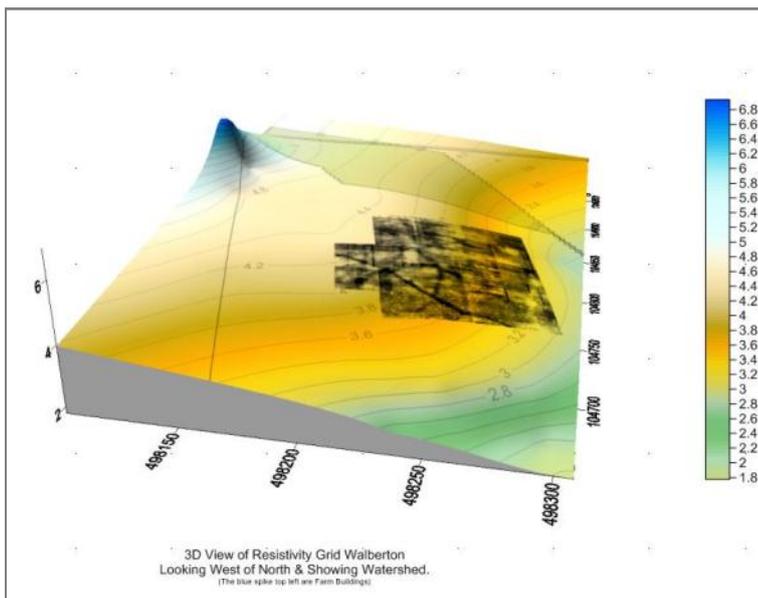
Figure 2. 3D view of the site with the Resistivity results superimposed. Note the plateau like nature of the site

The site is in the parish of Walberton, centred on SU 986047 at a height of c.4.5m above sea level. To the east the ground slopes sharply down to the Walberton rife, to the west there is a gentler slope into the adjacent field whilst to the south it slopes down to the railway track there being a break in slope at about the 3.5m mark. It therefore forms a fairly flat plateau surrounded on three sides by lower ground and is most likely a river terrace associated with the River Arun, which is c2km to the east (see Figure 2)

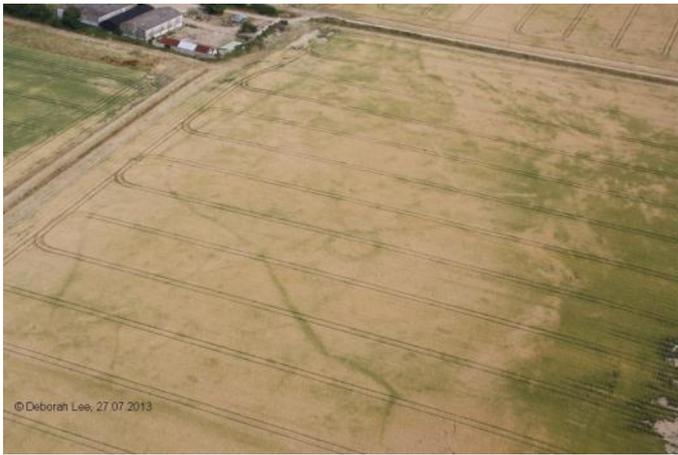
Figure 3a. Oblique view across the site from the southeast looking towards the grain drying facility. Note the strong linear feature running from bottom centre towards top left, also the central circular feature.

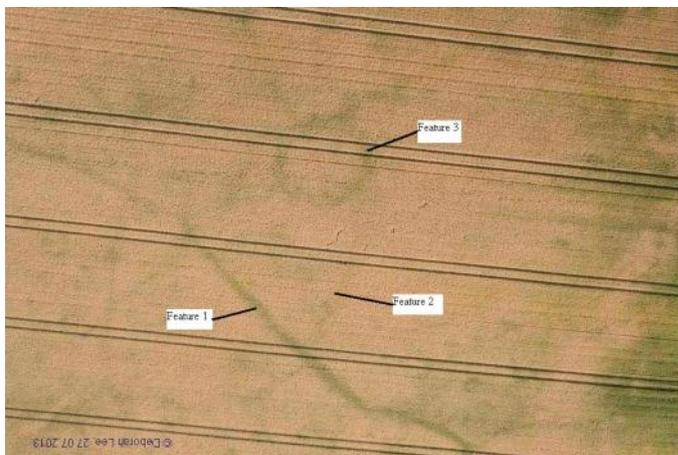
Figure 3b. View taken closer to the vertical of the central area of the field. North is to the top of the photograph. Note the strong linear and circular features.

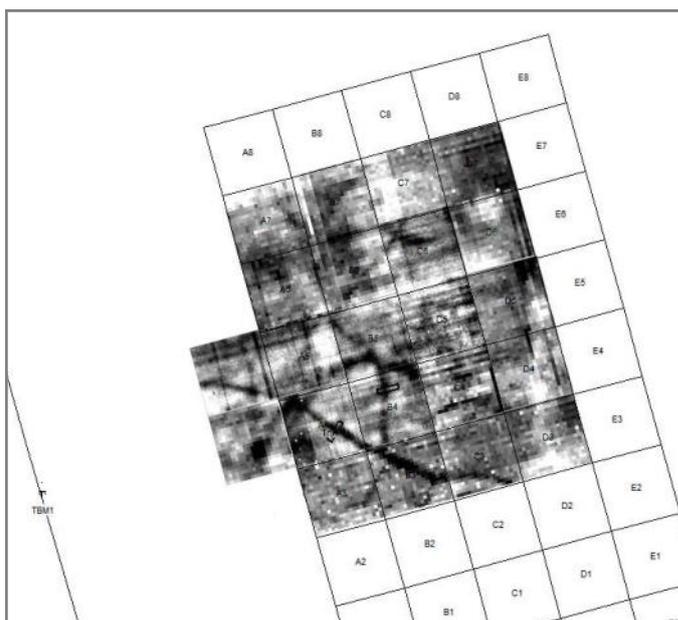
Figure 4. The results of the resistivity survey

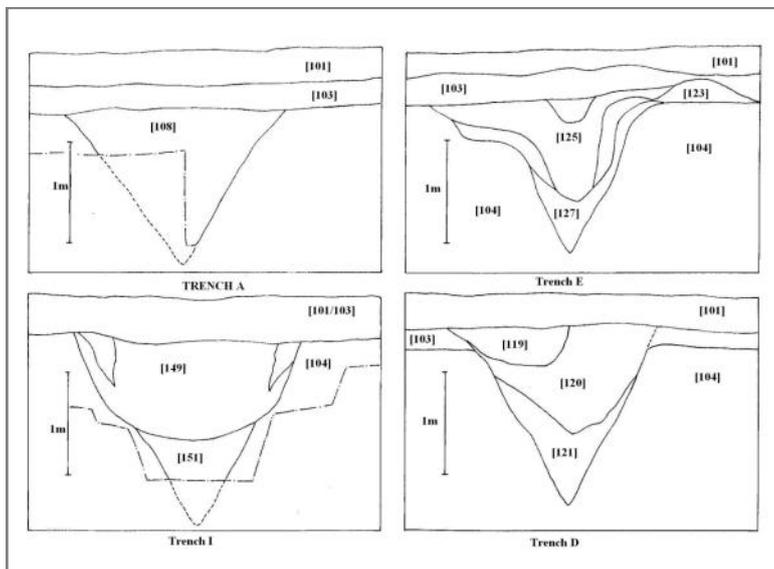
Figure 5. Sections across the ditch seen in Trenches A, D, E & I

This proved to be a ditch, maximum width 2.3m and maximum depth 2.10m, with steep sides (between c 55 and 70 degrees from the vertical) and a V-shaped profile (see Figure 5) It was sectioned in 4 places (trenches A, D, E & I) and was virtually identical in shape in 3 of the sections. The exception was Trench I where there appeared to be a very clear recut, the recut producing a shallower (1.36m deep) feature with a wide U-shaped profile. The fill of the ditch varied with locality, though a general pattern was that there was a lower fill of mottled clay with coarser material above and little apparent stratigraphy. No dateable artefacts were recovered from the any of the fill.

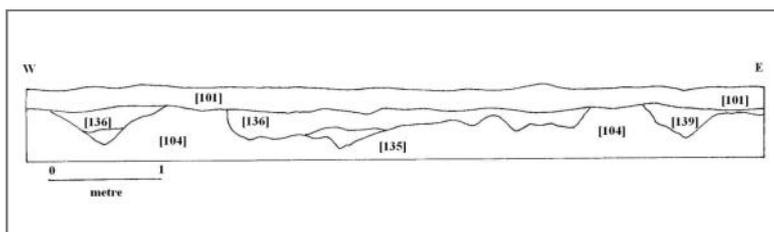
Figure 6. Section in Trench G showing the 'metalled area' with gullies to either side

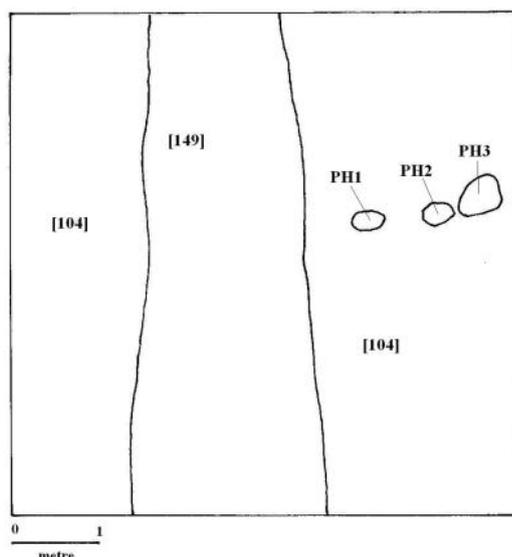
Figure 7. Plan of Trench I showing the ditch (context 149) with three postholes to the east

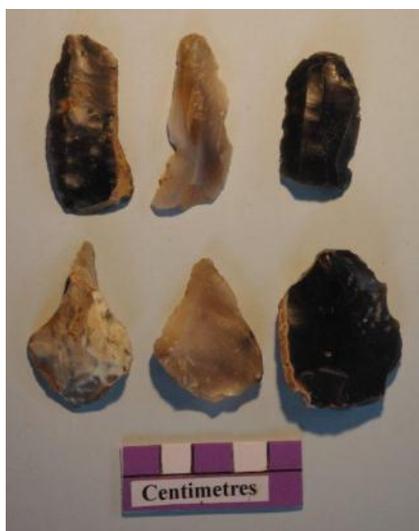
Starting top left (left to right)  
SF 608 Notched Blade  
SF 515 Backed Knife  
SF646 Piercer

Bottom left to right  
SF514 Backed Knife  
SF518 Piercer  
SF556 Retouched Flake

In taking the two years together, the tools total 145 of which 60 can be attributable to the Later Mesolithic/Early Neolithic period, 2 to the Neolithic, 50 to the Later Neolithic/Early Bronze Age, 33 to the Later Bronze Age.
