## Possible Medieval Well from the lost village of Cudlow, (Codelawe)

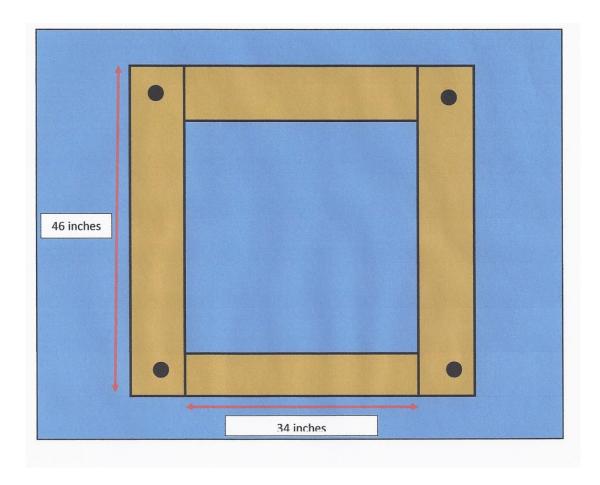
The structure comprises of timber beams, believed to be made from oak, arranged into a framed square and stacked into an unknown number of levels. However, during excavation a 27" long spade was used and when used to test how deep the stacked beams extended below the water line and surface of the mud/silt, a depth of approximately 3 feet was the maximum which could be achieved in the test but which still yielded the presence of the wooden structure and therefore suggests that the structure is at least greater than 3 feet in depth. Each beam measures 6" wide x 6" deep. The two beams arranged on the north/south alignment measure 46" in length whilst the two beams arranged on the east/west alignment measure 34" in length. In each of the four corners of the frame are drilled holes with what appear to be trenail fixings. Although it could not be seen clearly it is suspected that the beams are connected with tenon and mortise joints which have been secured with trenails.

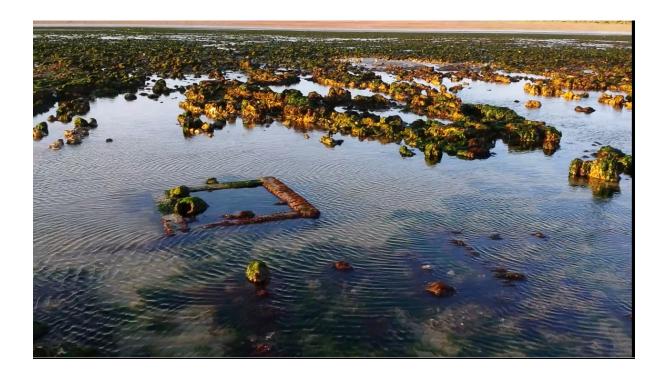
## Still image taken from video made of site before the removal of any pots
