# A report on the clearance of the Slindon House Stable Block by Worthing Archaeological Society, 2012/13

## A report on the clearance of the Slindon House Stable Block by Worthing Archaeological Society

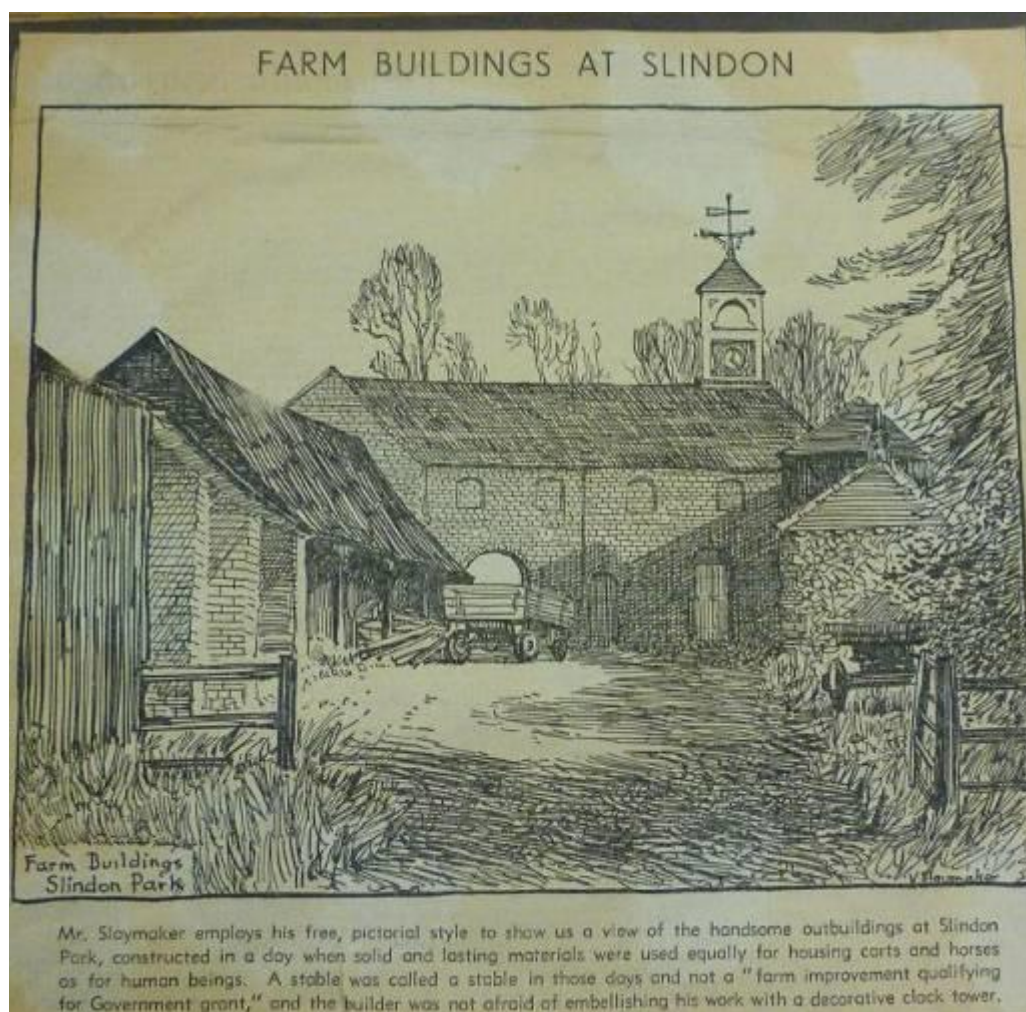
Fig.5 : The west wing, from a sketch published in the newspaper c.1930 by Mr. V. Slaymaker

Worthing Archaeological Society began to clear debris and vegetation from the stable block in the winter of 2012 and it was quickly apparent that the foundations of the building were in surprisingly good condition. First to be uncovered was the East Wing, adjacent to the Society's storage shed. This revealed a row of surfaces with a corridor alongside, separated by a skilfully laid channel made of five bricks laid on edge with a slight concave curve. There are two large areas and five smaller rooms with one more on the return at the southern end of the range. By their size we judge that these were loose boxes. Five of the rooms are paved with edgewise bricks, sloping slightly to assist drainage. The floors have been divided diagonally and a double row of bricks runs from the corner to the centre of the stall. Bricks have been skilfully cut slantwise to fill the triangular spaces created. Each of these rooms has a small central drain with a cast iron drain cover or an earthenware drainage tile. The three other rooms on this range are paved with hard-glazed, black, "chocolate block" pavers. These also slope to a drain. It is possible that these hard-glazed floors are a later alteration; the brickwork of the other rooms is very smooth and flush but the edges of these floors protrude and have a less finished appearance. The northernmost room is 12 ft wide, and may have replaced two stalls and the other two, which lie next to each other, measure 18ft wide, or three stalls width. The corridor is made from the same bricks laid on edge but here they are laid in a herringbone pattern.

Fig.6 : Brick forecourt, old North Wing, showing stable floors and drains

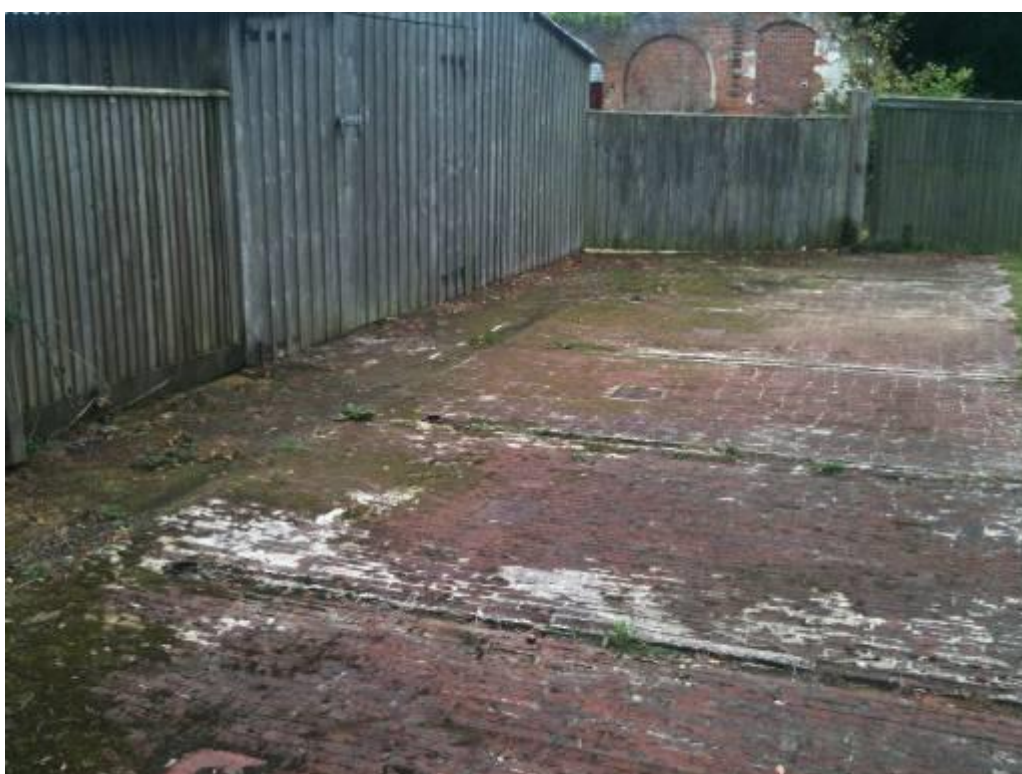
Midway along this range there is a brief change of surface to flag stones. (fig.7) Many of these are broken and laminating but one or two are sufficiently intact to show that they were once thick stones about 18ins x 12ins. They run through the wing from the outside towards the courtyard where a substantial threshold is still in place, creating a narrow passageway. This flagged passage corresponds to the archway that can be seen in the photographs. The passage way is crossed by the herringbone corridor which runs the whole length of this wing. There is a slight evidence of thresholds where the corridor crosses the passage, suggesting that there were doorways opening both north and south, giving access into the corridor. This fits with the layout of surviving stable blocks elsewhere. Going south, the corridor stops at the last loose box which makes the corner with the South Wing.

Fig.7 : Floors of stables, passageway and loose boxes on East Wing, and foundations of outer wall
